HMAS AE1

**Main Report –
Finding the Men
of AE1 –
20 December
2017**

**Version 2
November 2018**

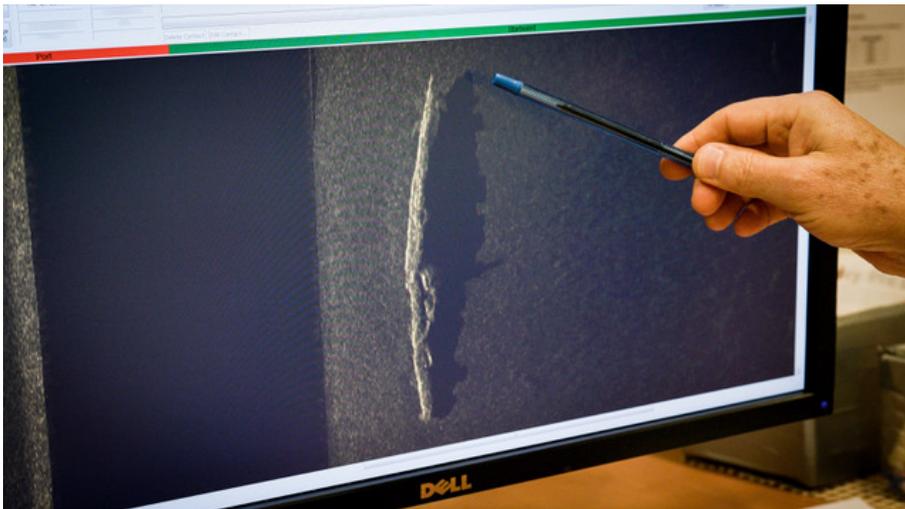
Figure 8 - First Contact FE-04, Ultimately Identified as AE1

As the team entered the processing room, the exultant smiles and sense of excitement of the two analysts were infectious. A contact had been detected by the AUV's side scan and multi-beam echo sounder sonars. The contact, identified as FE-04, was lying proud of a hard, flat seabed and exhibited a regular, long, narrow rectangular shape consistent with AE1's dimensions.

Further processing revealed that the long axis of FE-04 was aligned to the southwest. A long, linear sonar shadow extended upwards from the centre of the contact and offered the tantalising possibility that it was a periscope. On the presumption this was indeed a submarine, the imagery that would correspond with the forward and after casings were irregular and inconclusive, but vague acoustic returns hinted at what may have been the flat surfaces of the submarine's forward and after hydroplanes.

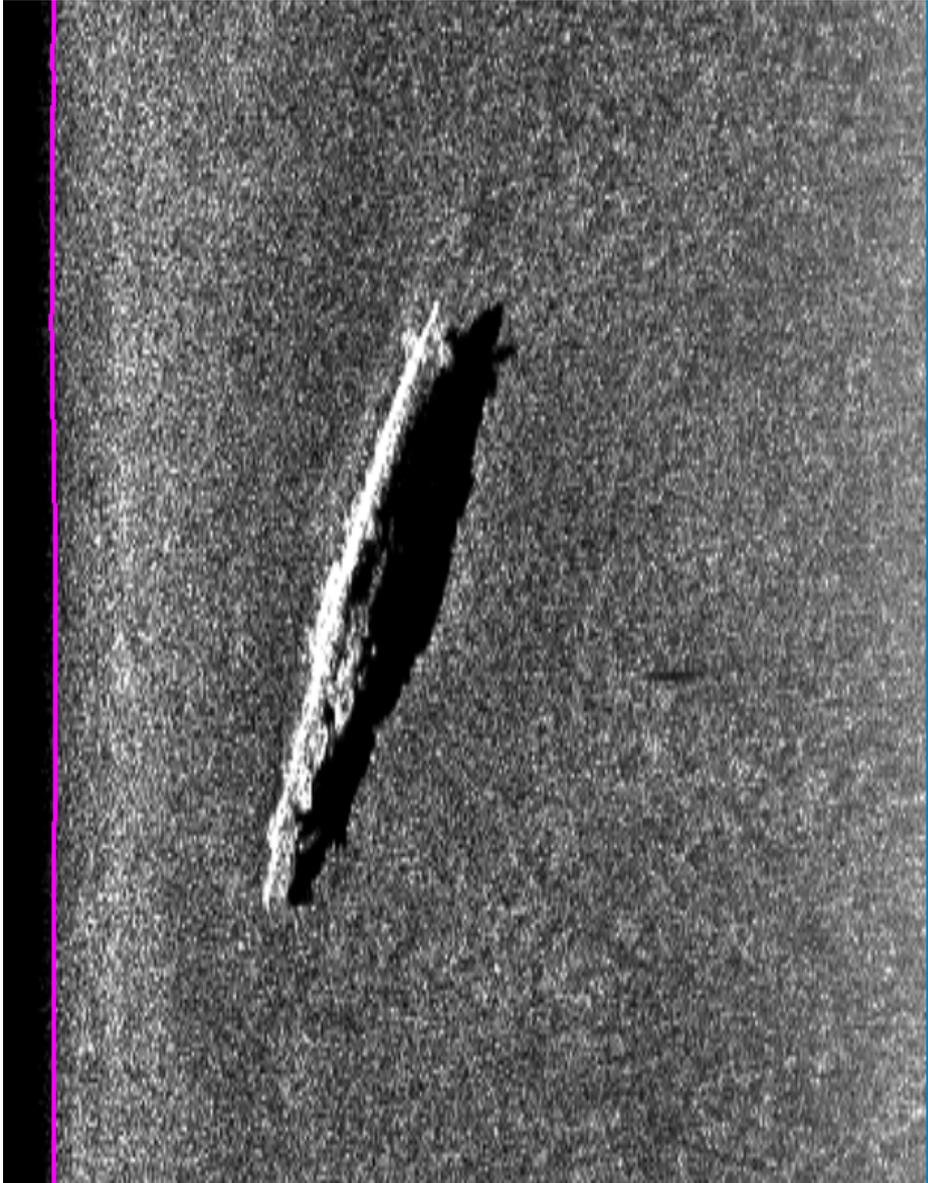
Figure 10 - Refined AUV Sonar Image of FE-04

The AUV was recovered at 0720 the next day and the data was available at approximately 0830. The new data further affirmed the submarine-like features of the contact, including the hydroplanes.

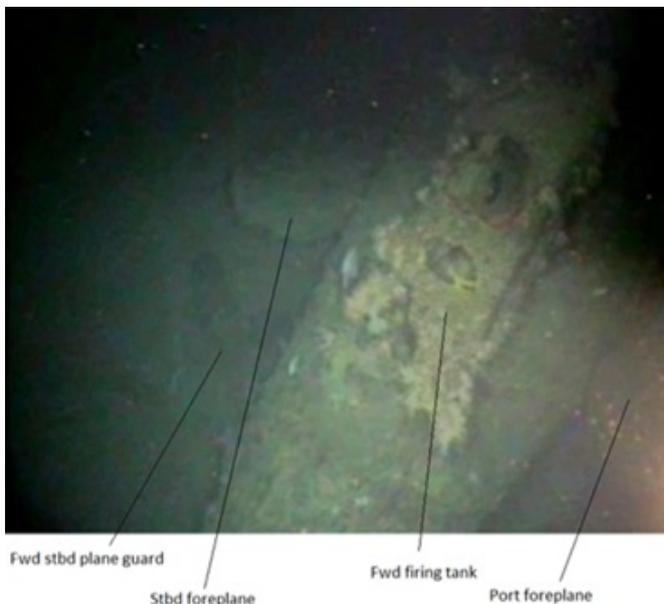
Figure 12 - First Sighting of AE1 - The Forward Starboard Hydroplane

The ship was manoeuvred to position the camera close to the southwestern end of Contact FE-04. The camera obtained visual contact with the bottom at 1052, 37 minutes after it began the 300-metre descent to the site. The ship's position was slowly adjusted to bring it over the top of Contact FE-04 and the first video imagery showed a narrow, man-made shape, with what appeared to be the starboard forward hydroplane in the foreground. As the camera moved across the wreck site, the port forward hydroplane came into view. Brief discussion among the Expedition Team followed, and all quickly agreed that the camera was positioned above AE1's bow. Both hydroplanes appeared to be at the "hard to rise" position, which truncated their overall appearance when viewed from overhead by the drop camera.

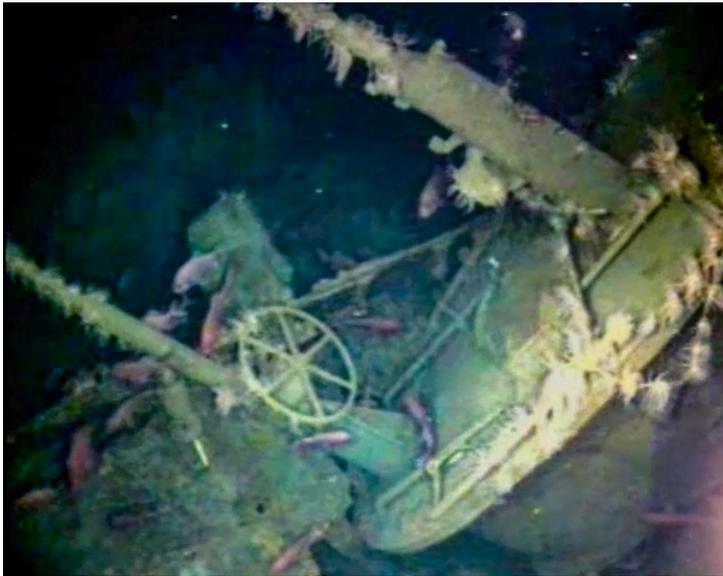
Figure 13 - AE1's Dislodged and Damaged Fin

Fugro Equator was manoeuvred so that the Drop Camera gradually moved aft along the starboard side of AE1. The keyhole overhead perspective provided by the video camera yielded some confusing shapes and shadows – the submarine's surviving hull showed signs of extensive damage and the fin, when it came into frame out of the gloom, was out of position and listing at a strange angle. After some time examining the stern, sighting the after hydroplanes and port screw, the camera was then moved forward along the port side of the pressure hull. It was here that the team observed that the fin (the casing that contains the conning tower) was torn from its footings and angled over to starboard.

If there were any doubts remaining about the identity these were banished by the sharp images of the features of the fin, bridge and bridge helm positioned on the forward periscope standard. The Drop Camera serial finished to a round of applause and sighs of relief in the control room –AE1 and its crew had indeed been found. The lights of the Drop Camera were the first rays to illuminate the submarine since that fateful day, 14 September 1914.

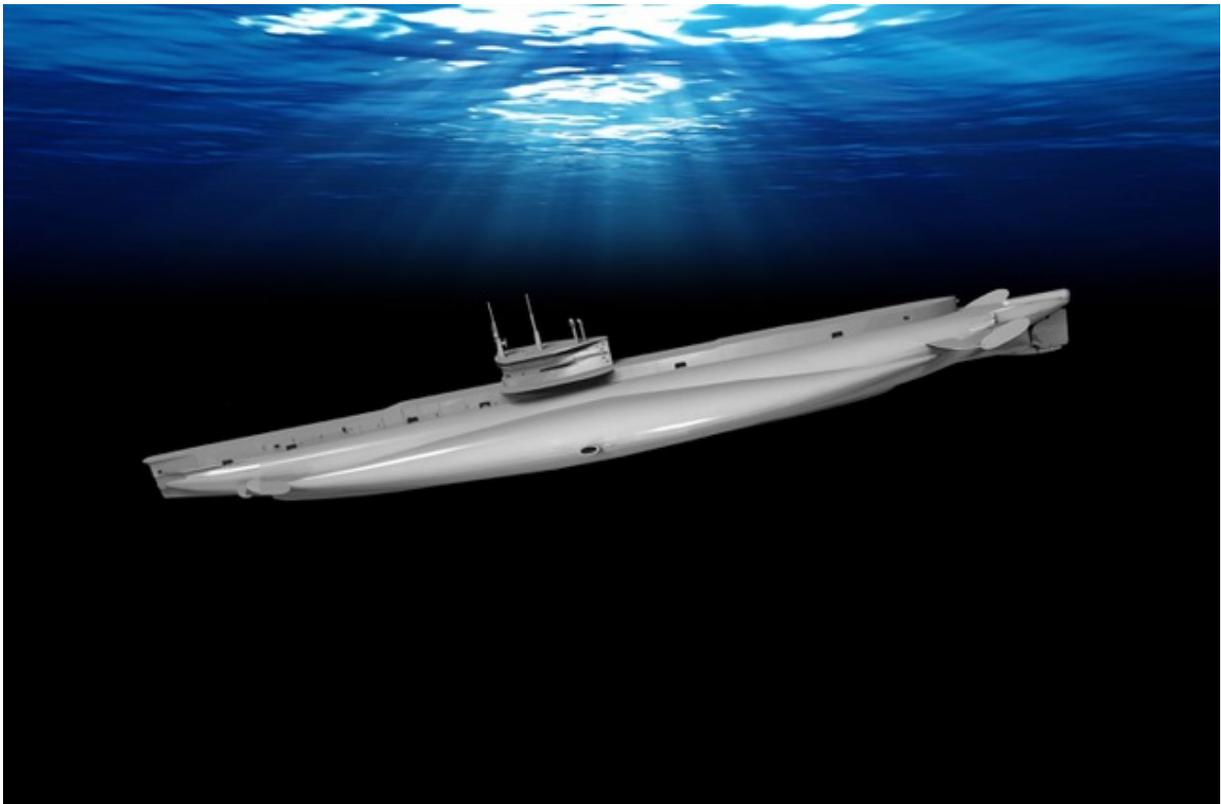
Figure 15 - Graphic Sequence of Sinking Process – Dived, with heavy trim trying to return to the surface, Hydroplanes "hard to rise"

⁸ *AE1*'s forward hydroplanes leading edge are angled up, providing positive lift to the bow and submarine overall. The after hydroplanes control the aspect of the submarine, bow up or bow down. *AE1*'s after hydroplanes leading edge is angled down, resulting in an effort to lift the bow. A bow up angle on the submarine will cause it to head towards the surface. Hence, both hydroplanes are said to be "hard to rise".

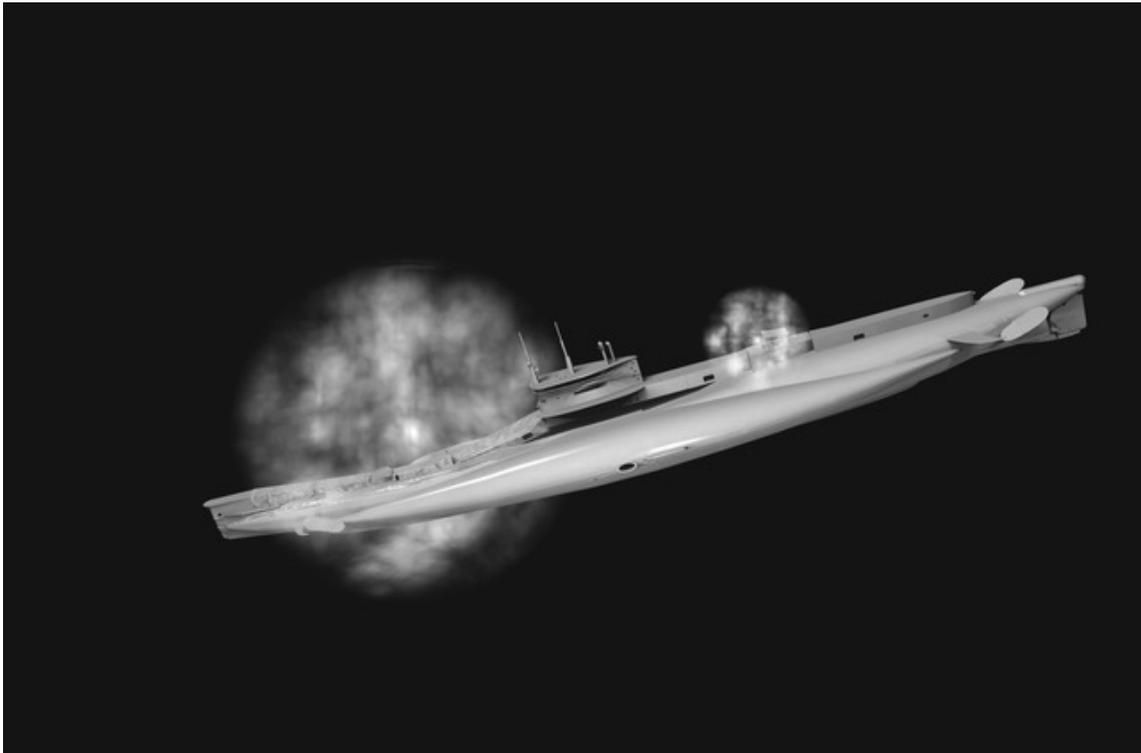
Figure 16 - Graphic Sequence of Sinking Process – Implosion as SM Exceeds Crush Depth

The hull over the control room and forward torpedo compartment implodes and instantly floods with great force. As the implosion's pressure wave moves aft, it blows the engine room hatch clear of the submarine. The crew are killed instantly. The fin movement forward may have commenced at this point.

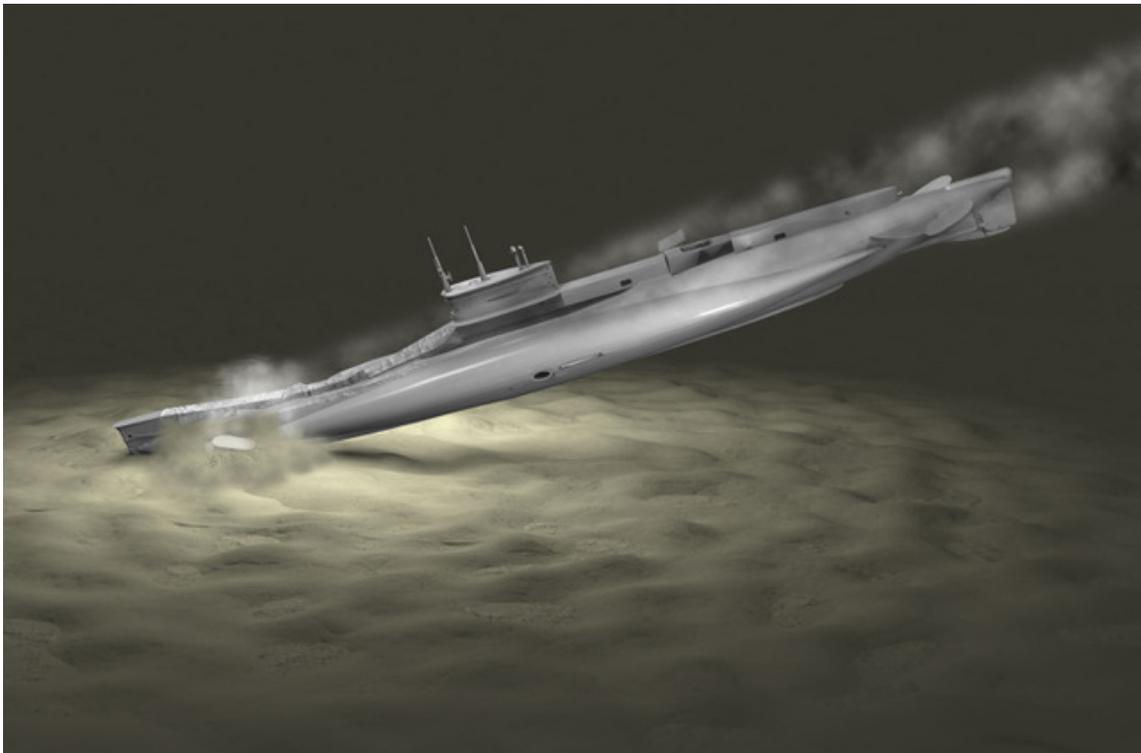
Figure 17 - Graphic Sequence of Sinking Process – Initial Impact

The flooded submarine sinks rapidly and gathers speed as it plunges towards the seabed. The hull strikes the bottom at a 10-to-20 degree bow down orientation and absorbs the impact on the leading end of the keel.

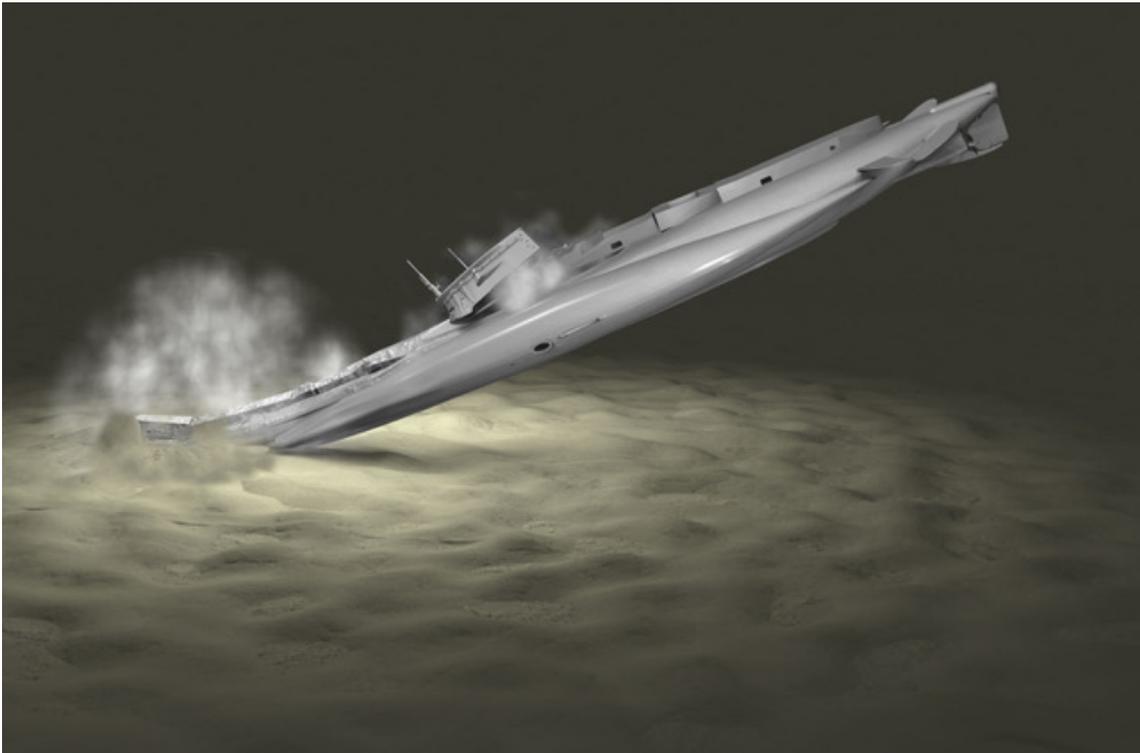
Figure 18 - Second Impact, Pitch forward, whiplash effect on Fin

- The hull maintained a moderate bow down angle [15-30 degrees] as it descended through the water column as the bow torpedo tube is relatively undamaged, but ultimately pitched forward on striking the bottom, as illustrated in Figure 18.
- The impact of the bow against the seabed probably generated a "whiplash effect" that caused the dislodged fin to hinge forward and pivot around the forward edge of the join between the upper and lower conning tower sections. This is evidenced by the current position of the fin (Figure 21). It is also possible that the implosion commenced this process.
- In all likelihood, there was little sedimentation to cushion the submarine's collision with the bottom. This is based on the current appearance of the seabed surrounding the surviving hull, which is hard, flat, and appears to be regularly scoured by strong, seasonal currents.

It is probable that the momentum from the initial impact carries the submarine forward and cause the bow to strike the bottom a second time. This generates a "whiplash effect", completing the dislodgement of the fin, which hinged forward, possibly on the leading edge of the seam in the conning tower. The fin ultimately comes to rest in the debris of the submarine's forward casing.

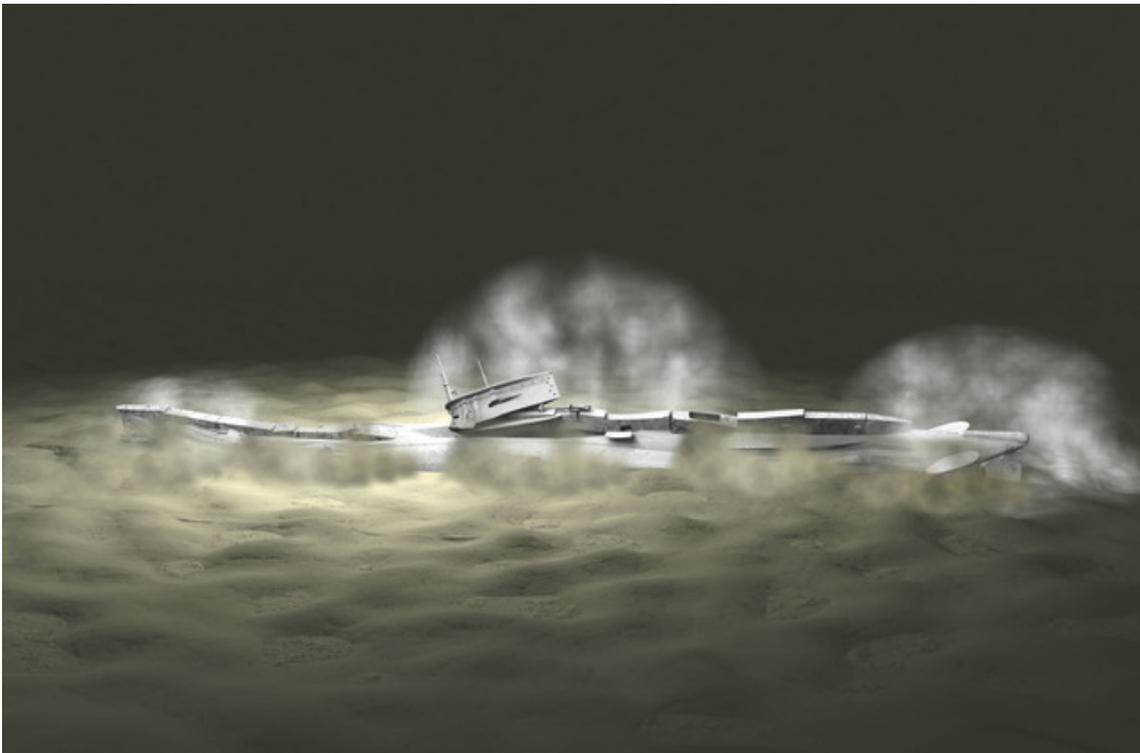
Figure 19 - Third impact, Submarine settles heavily back on Keel

Gravity causes submarine's hull to fall back towards the seabed. It is plausible that the force of AE1's keel striking the bottom probably dislodged the hydroplane guards, which fall away and land on the seabed just beneath their normal mounted positions on the hull.¹¹

¹¹ It is possible that this is the result of corrosion causing the failure of the securing arrangements. The Expedition Team consider this less likely given the consistent failure of all four guards, displacement of the port after hydroplane guard and continued integrity of AE1's sister submarine's AE2's hydroplane guards.

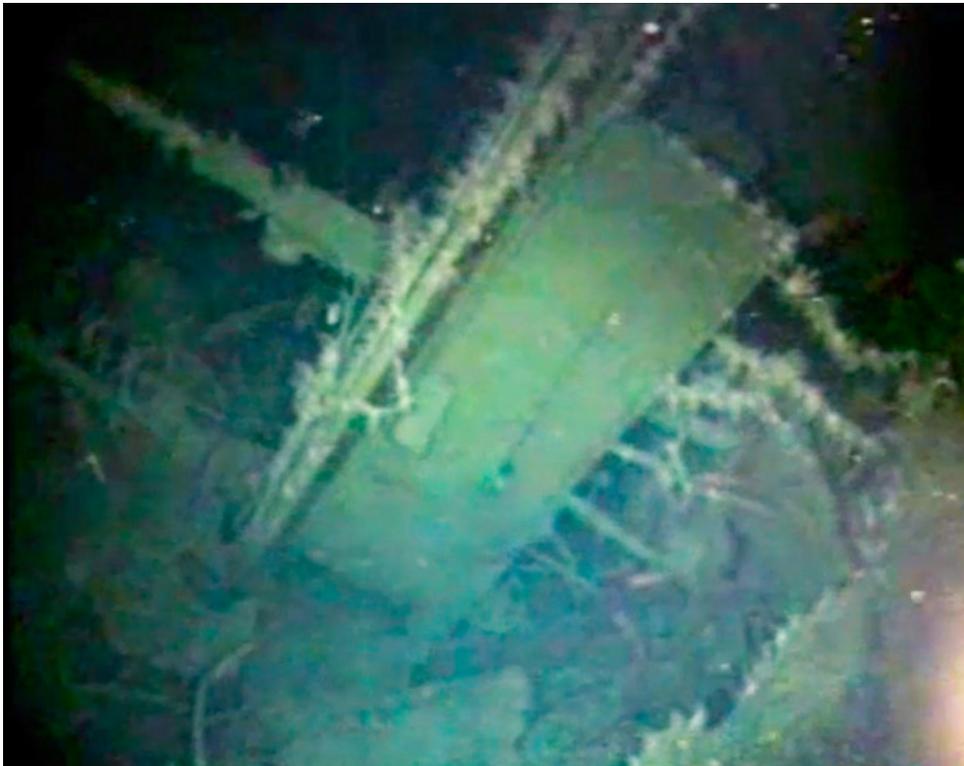
Figure 21 - Conning Tower Wheel and Ladder Revealed by Fracture of Conning Tower

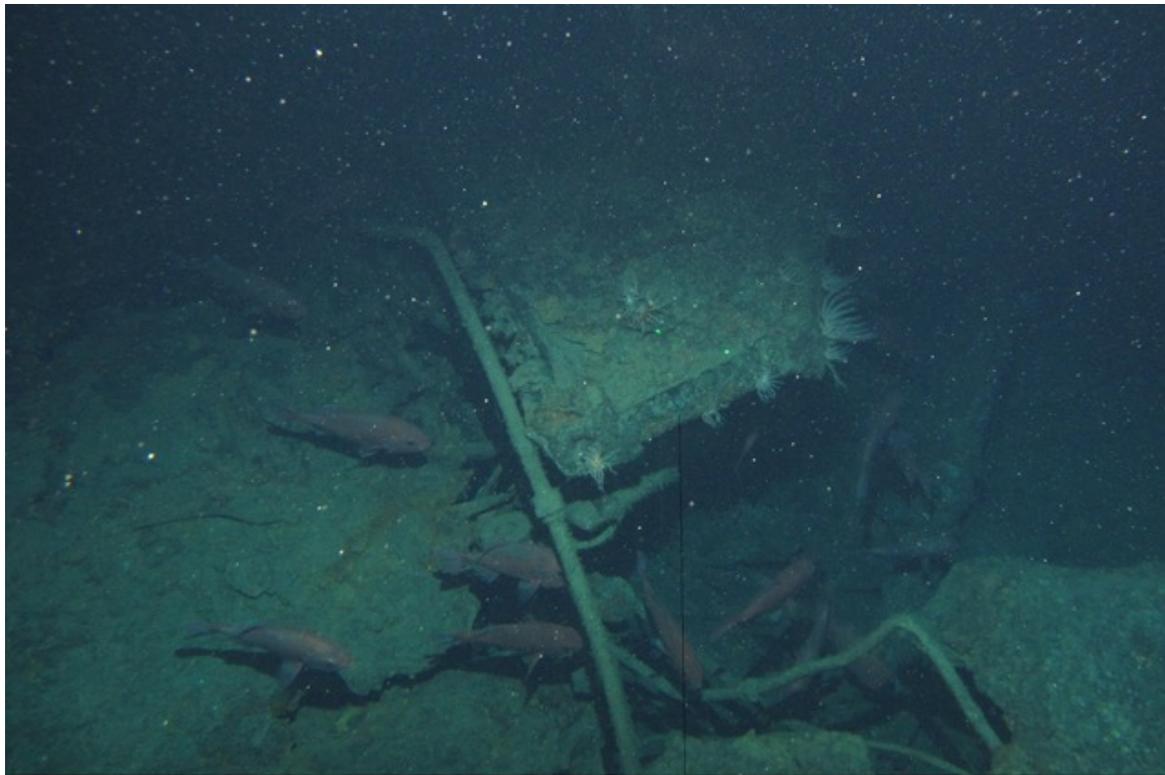
Corrosion of *AE1*'s metallic components, in concert with other natural processes (such as biological activity, currents and sediment scouring), have no doubt had a detrimental effect on the wreck site. In the worst cases, these processes have probably contributed to structural damage to the hull and had a negative impact on the preservation of organic and non-organic artefacts and features.

Figure 22 - Ruptured Pressure Hull Plate Damage Forward of the Fin

Pressure hull (riveted) plate rupture over main switchboard

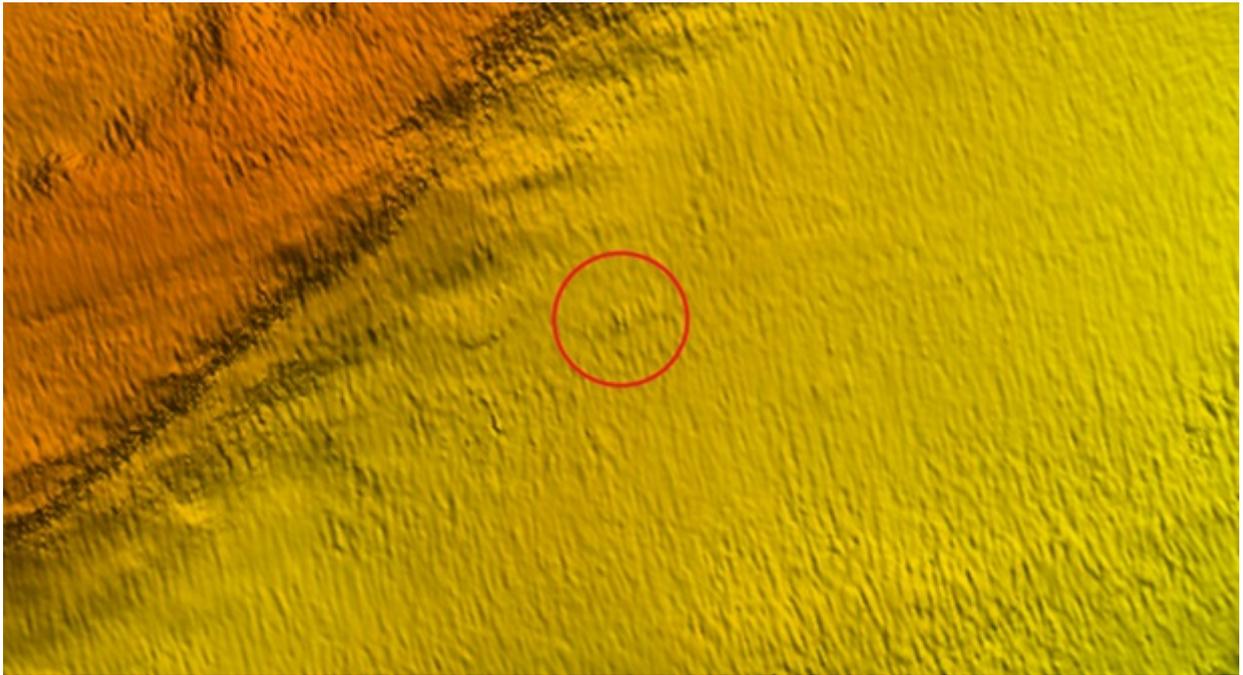
Figure 23 - Inconclusive Detection of AE1 during November 2015 Search from Fugro Analysis

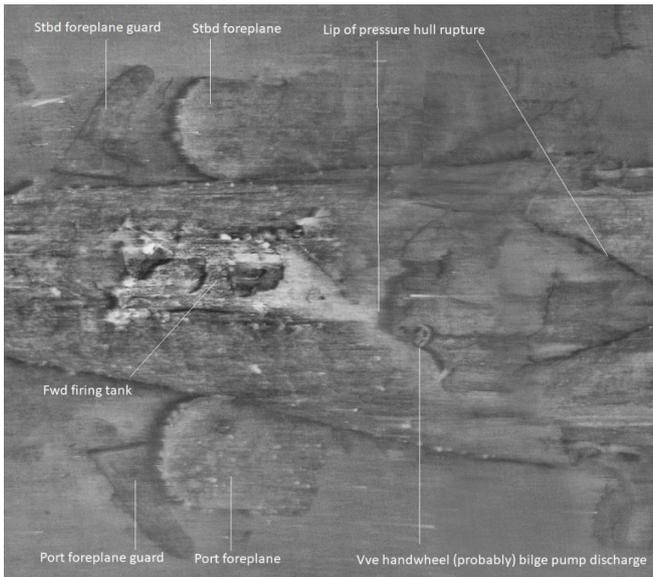
Figure 4 – Forward Hydroplanes & Hydroplane Guards + Handwheel (probably Bilge Pump Outlet vve)

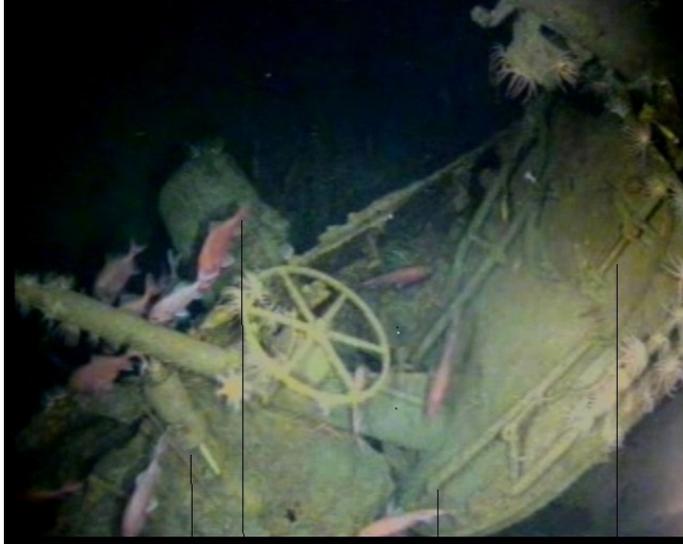
Figure 7 - Fin Area (B)

WT antenna stump

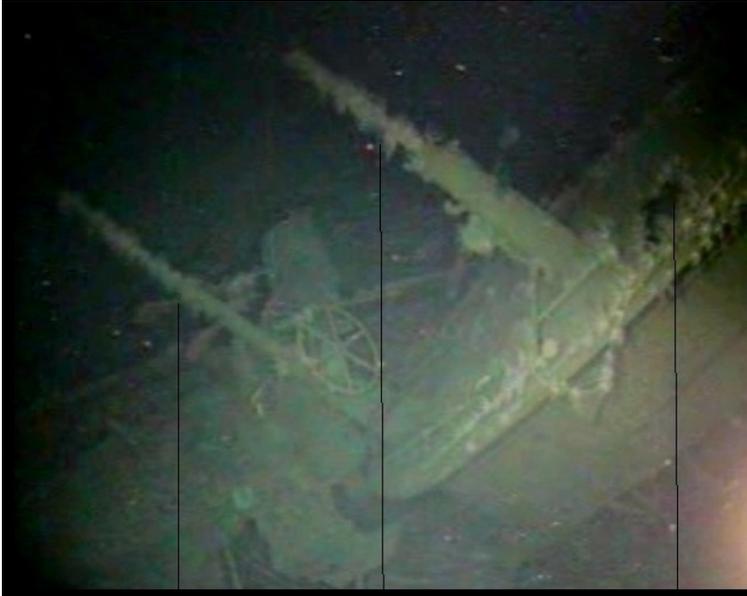
Figure 8 - Fin Area (C)

Fwd periscope in raised position

After fin access hatch with hatch cover missing

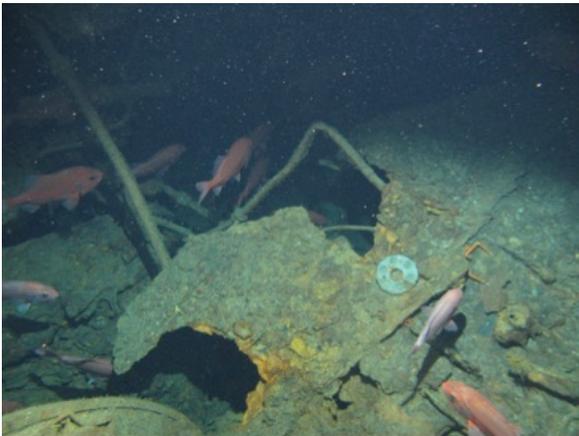
Figure 11 - Casing & Riveted Pressure Hull damage to Port and forward of the Fin

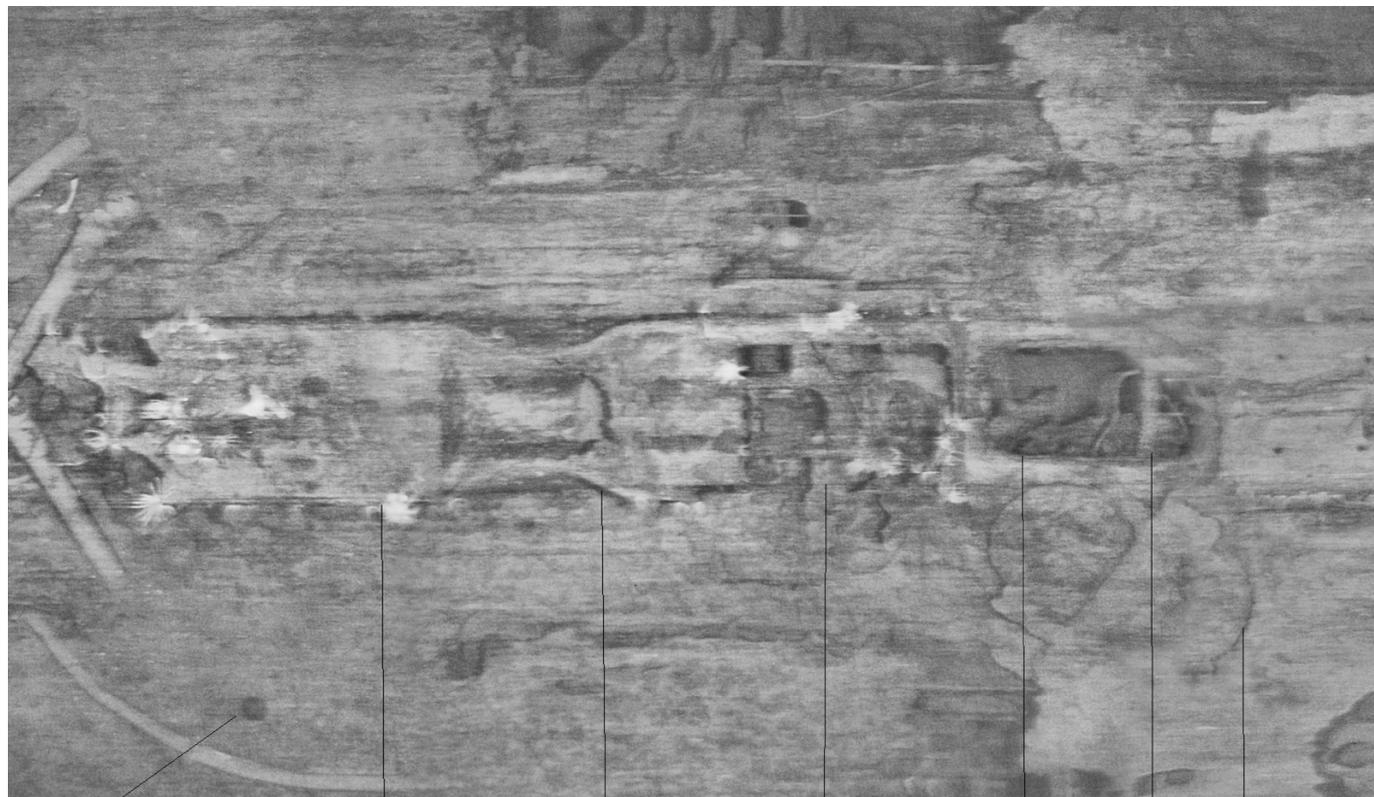
Figure 12 - Beam Torpedo Tube Firing Tanks & Engine Room Hatch Area

Curiously regular hole in
port saddle tank

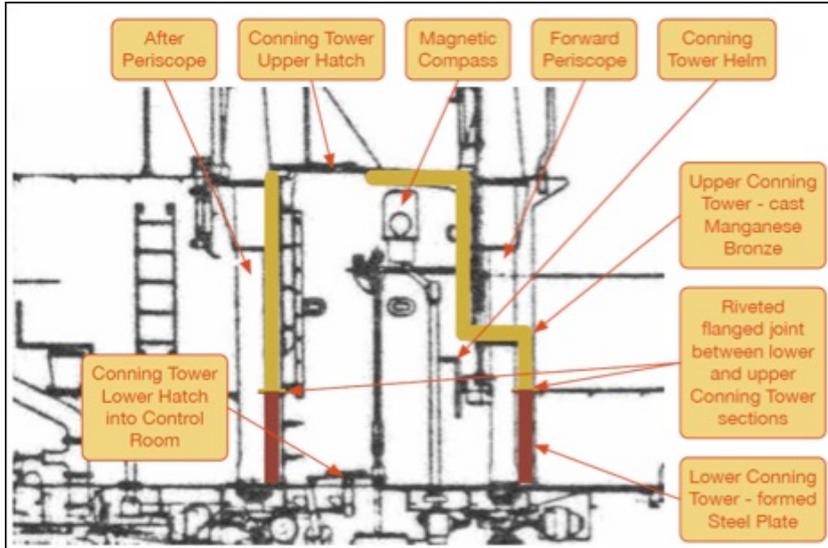
Figure 19 - Extract of Plans to illustrate Fin Failure Mode

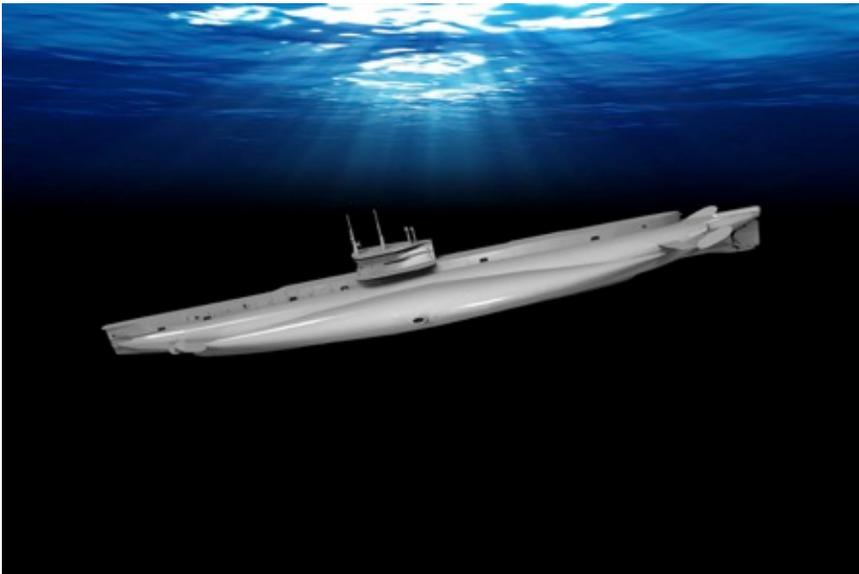
Figure 20 - *AE1* Diving or Dived at or near Periscope Depth suffers an Accident resulting in her losing Trim (Assumes a Bow Down Angle)

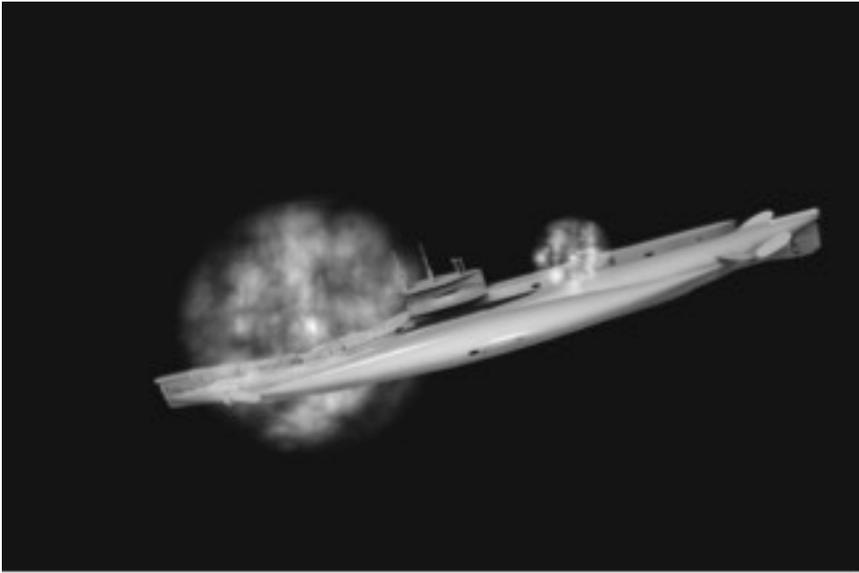
Figure 21 - Unable to Recover, she carries on down until reaching Crush Depth when the Control Room and Forward Area Implodes. The Shock Wave Blows off the Engine Room Hatch

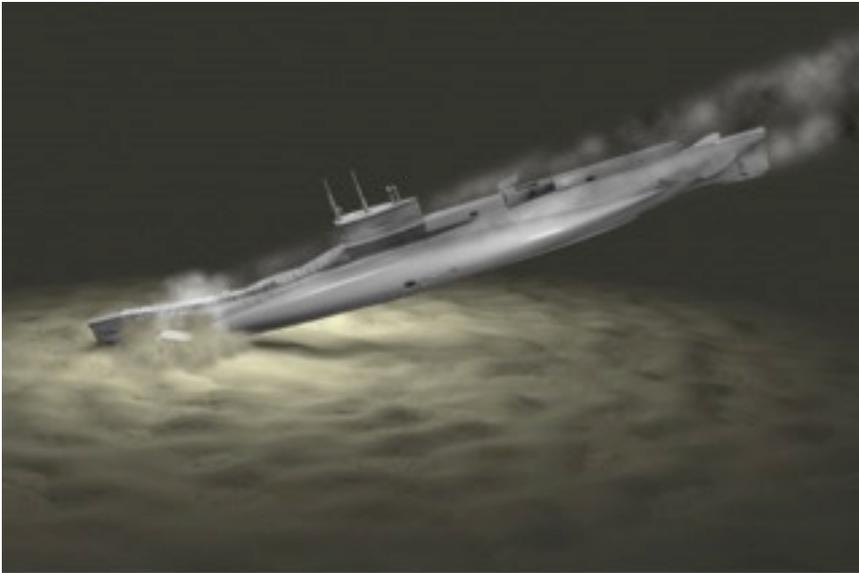
Figure 22 - AE1 continues down, gathering speed until she strikes bottom at an angle of up to 30 degrees

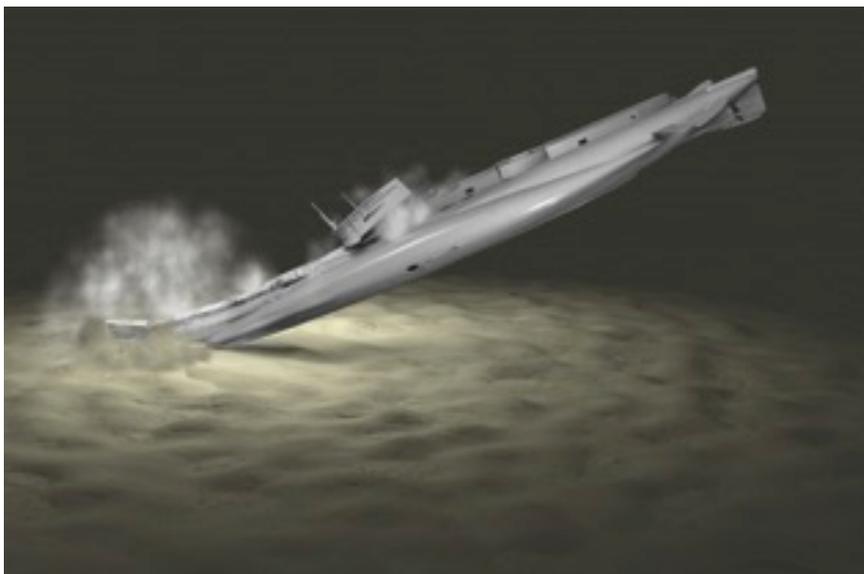
Figure 23 - Momentum causes the Fin to topple into the imploded Control Room and then for the Upper Conning Tower to hinge forward on its forward edge separating its flanged joint with the Lower Conning Tower

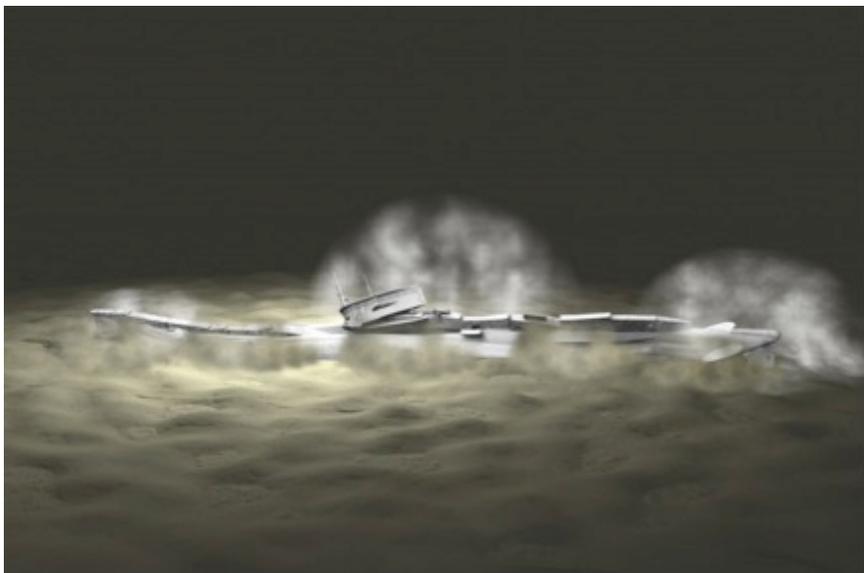
Figure 24 - The Hull falls back onto its Keel resulting in a second wave of damage, including dislodgement of the Hydroplane Guards
