**OPERATION SILENT ANZAC**

**INTERIM REPORT ON THE MARITIME  
ARCHAEOLOGICAL ASSESSMENT 2014**

**HMAS AE2**

## Project Silent Anzac Maritime Archaeological Assessment 2014 Interim Report

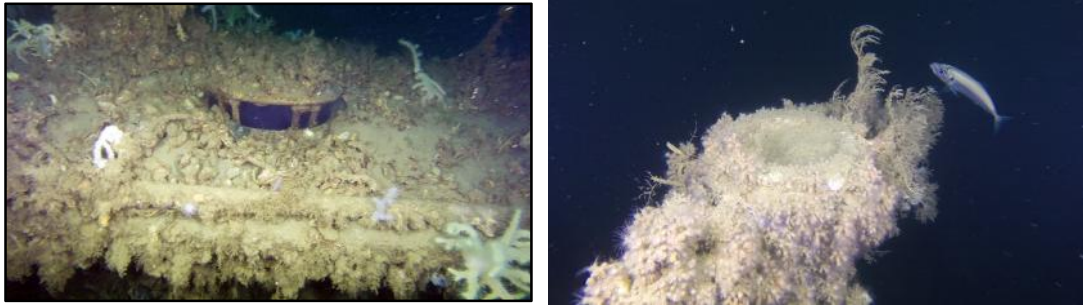
The ROV completed an external survey; good imagery was obtained and no major changes to AE2's appearance from the 2007 and 2013 surveys were noted. A diving medical emergency evacuation exercise was held, followed by a dive to clear away debris from around the hatch to avoid this entering the submarine during future serials.

**Figure 9 Conning Tower Hatch on first approach and forward periscope pedestal**

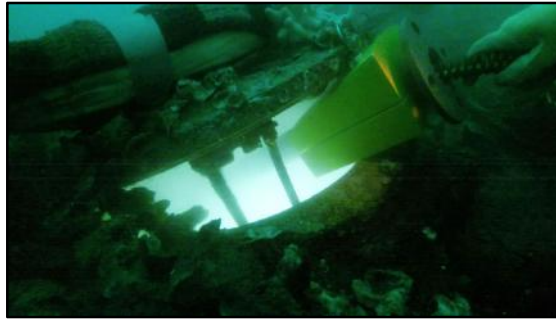
20. Wednesday 11 Jun 14. The stirrups were cut through and the hatch opened 3cm by hand, enabling the drop camera to be inserted during the second dive serial. Good images were recorded in the control room however visibility in the conning tower was poor due to the disturbance caused by the cutting and insertion. The drop camera was left inside the SM overnight in the hope of better visibility in the morning.

Figure 11 Drop camera illumination showing remaining hatch stirrup in place

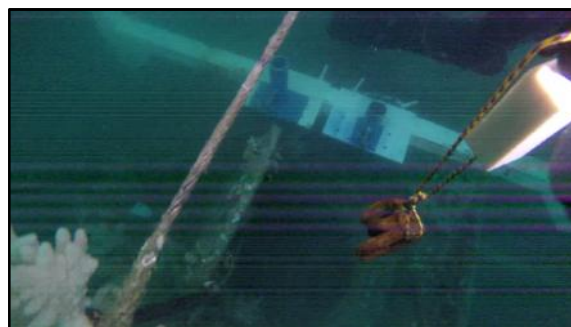
During the final dive for the day the hatch was opened to the near upright angle of 85 degrees using a chain block and secured in this position. A build-up of silt, shells and concretion obstructed further movement. This opening proved adequate to insert the ROV, avoiding the need to cut the hatch away. It is a testament to the submarine's designers, the ship builders and the Engine Room Artificer responsible for the maintenance of equipment outside the pressure hull adherence to the maintenance routines that the hatch bearings operated correctly after 99 years on the seabed!

Figure 13 ROV being inserted into open hatch. Shows instrument mount in place and ROV weights

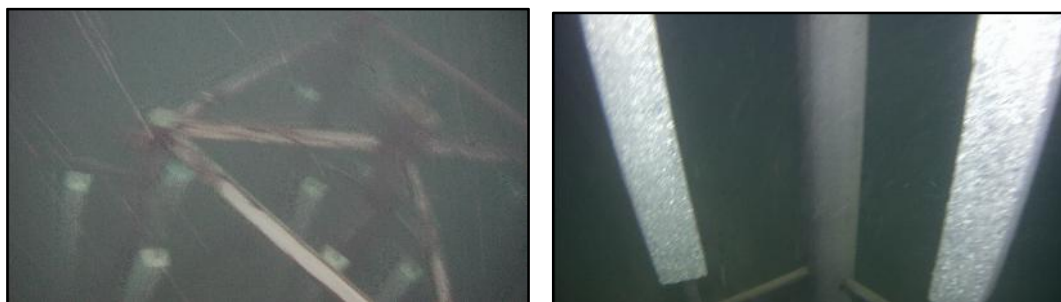
Figure 14 Anode pod in position. Same pod after 48hour connection showing depletion initiation has taken place.

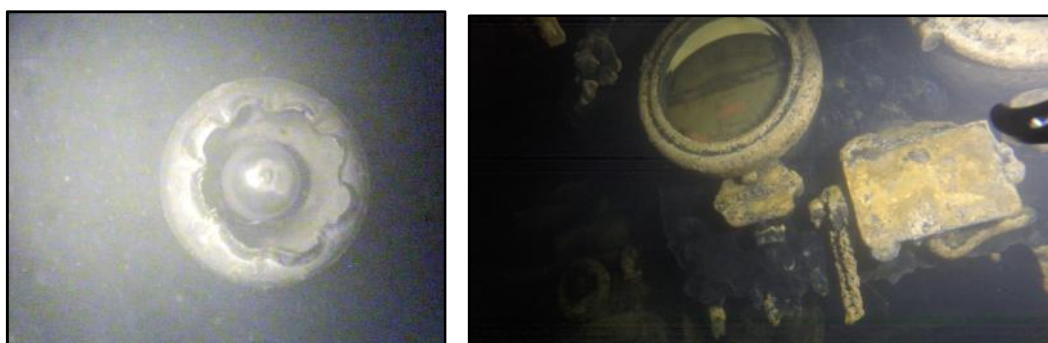
Figure 17 Tuesday's shots of the day; Captain Stoker's desk light and the Control Room Log

Images have been recorded from the Control Room through the wardroom, to the fore-ends and back taking in many equipments, artifacts and curiosities providing an unprecedented insight into early submarine construction and operation. Curiously only fragments of the spokes of the steering wheel, fore and after planes control wheels can be discerned, presumably these have

corroded away; providing a conundrum for our corrosion team. Among the many images, most memorable were the wooden wardroom furniture, the fluted light shade over the Captain's desk and the port decanter that sits intact on his desk.

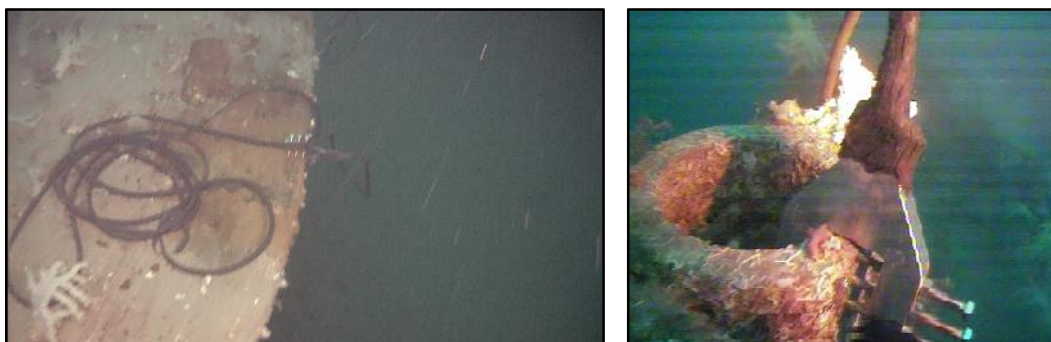
Figure 18 After CP connection to port hydroplane. Midships CP connection to periscope pedestal

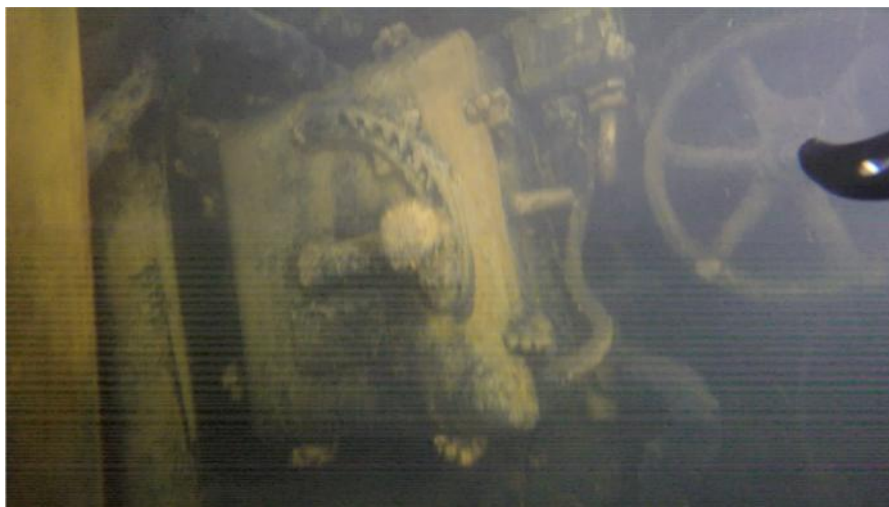
Figure 4 The First Images - Starboard Ballast Pump Controller

30. The process of post-processing the imagery gathered by the DSTO ROV has just begun. Already it is apparent there is much to learn from the data. To cite just one example, the wheels of the two hydroplane controls and the main helm have corroded away to stubs. This contrasts to virtually every other control wheel inside the boat. It would appear these three wheels were aluminum. Was this to make them lighter for the crew members to turn? This has not yet been debated or considered by the team. What is apparent though is that, while they lasted, these wheels played the role of sacrificial anodes.

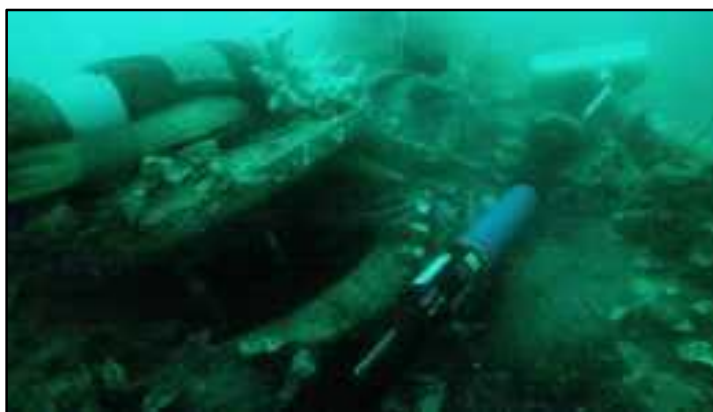
Underneath this dense layer of  $\text{CaCO}_3$  there will be zero dissolved oxygen and the anaerobic bacteria in seawater will have produced sulphide ions which will have resulted in a chalcocite or copper (I) sulphide ( $\text{Cu}_2\text{S}$ ) protective layer on top of the bronze which will have preserved all the original wear and manufacturing marks. The massive amount of secondary concretion on the hatch amounted to a thickness of approximately 30 cm that presented the divers with a challenge of how to get the conning tower hatch to move backwards. This problem was overcome with a combination of mechanical action from deconcreting tools, localised precision pressure from a hydraulic jack inserted into the nominal 10 cm opening of the hatch (see Figure 1) and the application of a chain block to pull the lid opening to a near vertical position.

Figure 1: The partially opened de-concreted hatch cover

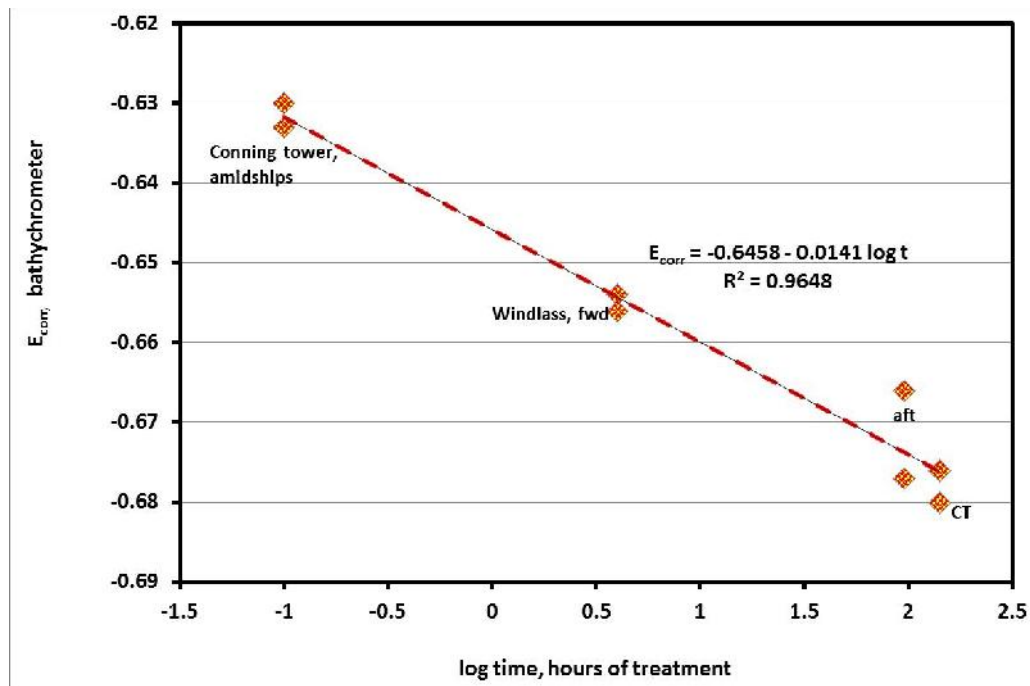
potential data ( $E_{\text{corr}}$ ) is plotted as a function of the logarithm of the elapsed time since application of the anodes it can be seen that there is a linear trend towards more negative  $E_{\text{corr}}$  values with the log of time – see Figure 5. Since all the data points follow the same trend this indicates that there are common mechanisms involved in pulling down the  $E_{\text{corr}}$  values.

cathodic protected  $E_{\text{corr}}$  of the conning tower was 50 mV after 141 hours or close to 8 days. This voltage drop is the equivalent of a 42% drop in the corrosion rate of the submarine!

Figure 5: Plot of the  $E_{\text{corr}}$  values vs. log time (hours) after application of anodes

One of the most significant features is the measurement of the conning tower before and after 8 days following the anode pod at that location. The fall in the  $E_{\text{corr}}$  values is proof that the system is working. Because the corrosion current has a logarithmic relationship with the voltage, a fall of 50 mV is a very significant fall when the massive surface area of the submarine is taken into account. There is also a logarithmic relationship with current and voltage that has been empirically and experimentally observed that for corroded concreted marine iron. The equivalent voltage drop of approximately 330 mV is needed to bring about a ten-fold decrease in the rate of corrosion. An image of the corroding anodes after 2 days at the central pod, attached at the conning tower, is seen in Figure 6.

42. While comparison of corrosion potential measurements taken pre- and post- installation of the anodes indicate the cathodic protection system is working, it is imperative a set of check measurements be taken after a reasonable settling period. The proposed 2015 check survey should include visual inspection of all anode pods and connection points plus recording of a set of corrosion potential measurements taken at each of the connection

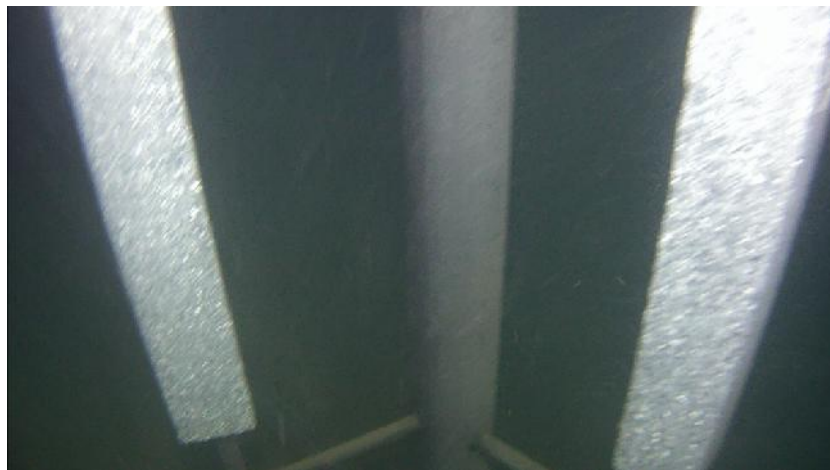
Figure 6: Corroding zinc anodes on the amidships pod two days after connection.

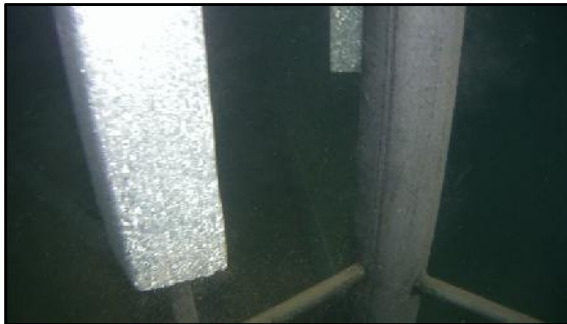
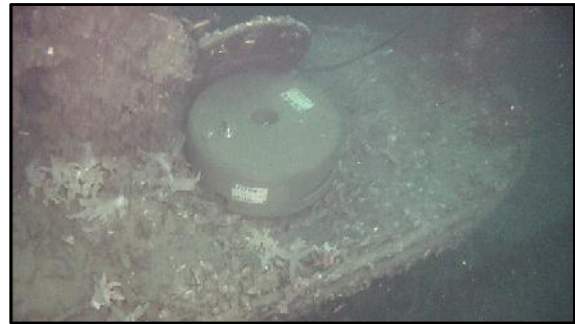
Figure 17 After anode pod after 48 hours of depletion; Hatch closure device (Top Hat) in place
