Finding Australia's First Submarine

HMAS AE1

14th September 1914

Search Area Recommendation

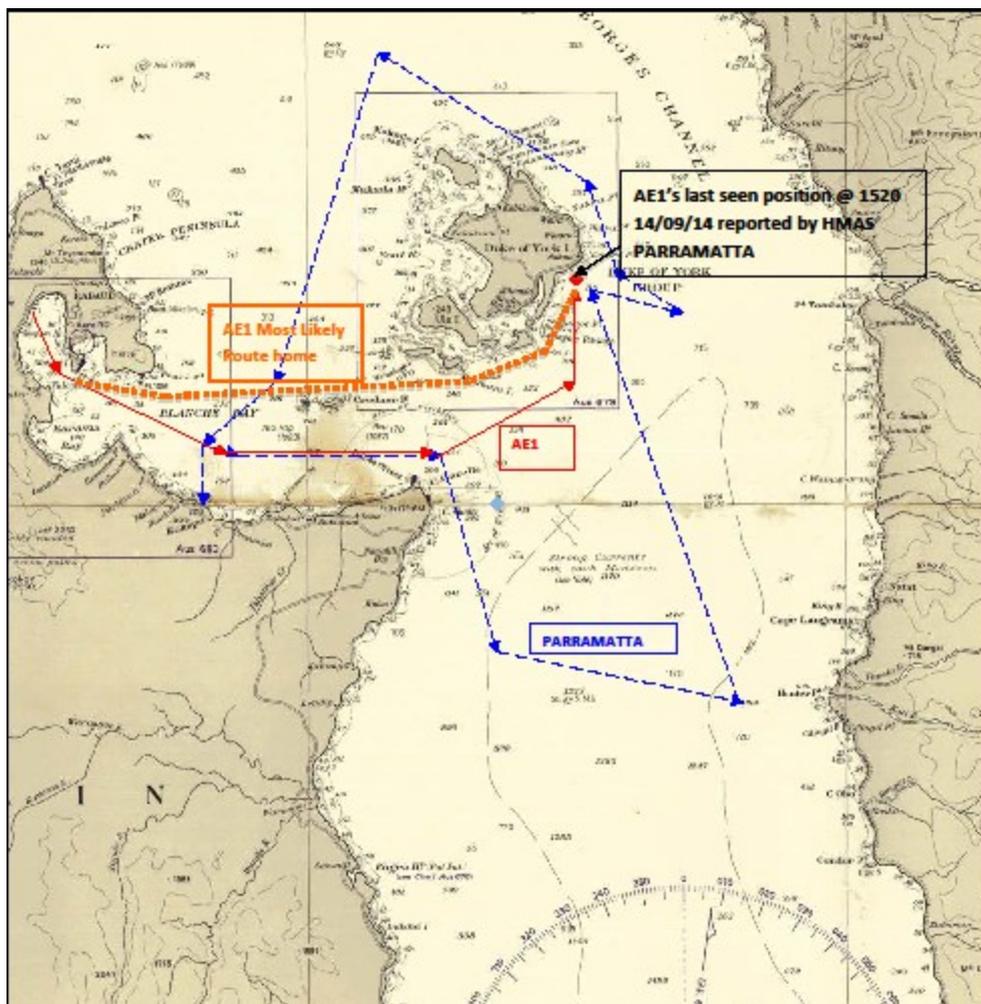
Figure 1 – AE1 & HMAS PARRAMATTA's estimated tracks during the patrol on 14th September 1914

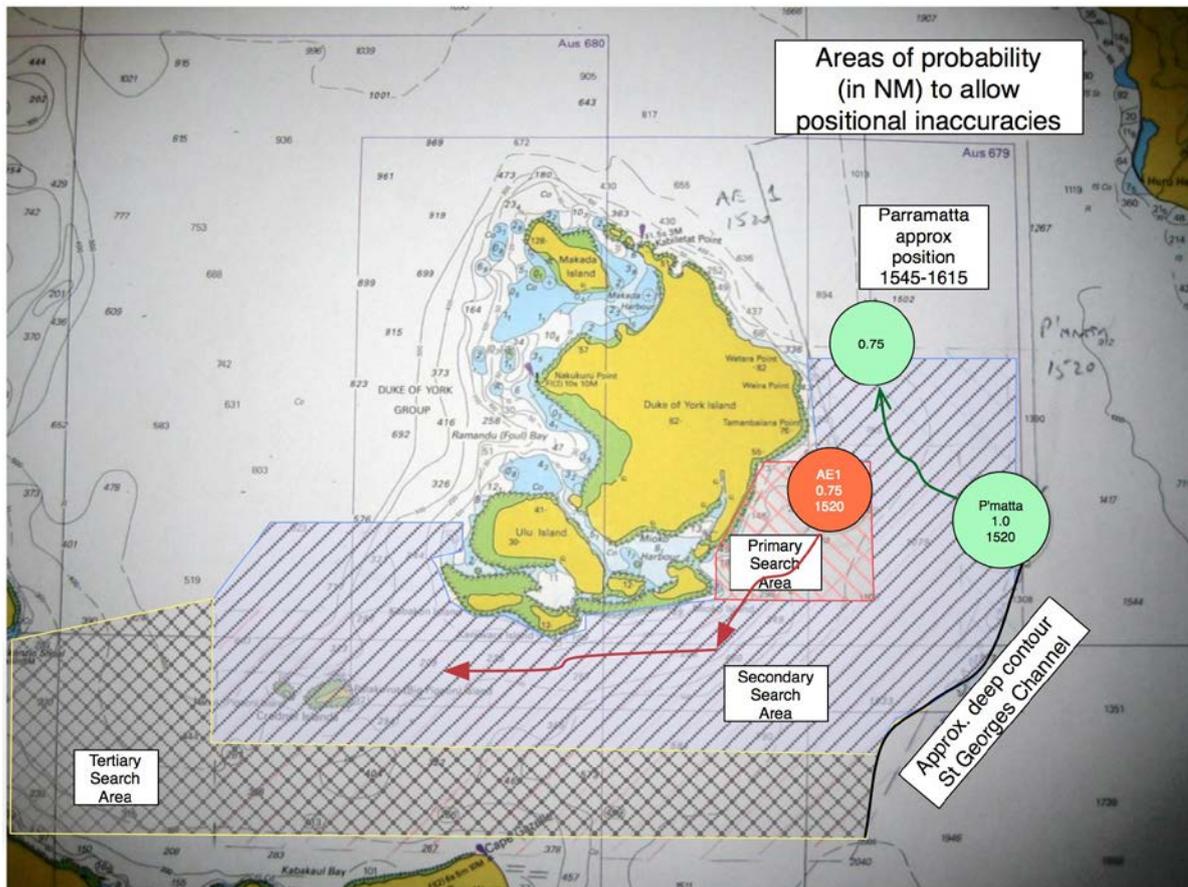
Figure 2- Recommended Search Area

28. From this analysis, we are able to recommend a search area that takes account of the likely grounding area, direction of drift as the submarine settled on the bottom and impact of the bottom topography on the final position. [7.2] The primary area is about 5 Sq NM of which 15-20% is deeper than 300 metres. The secondary area is approximately 62 Sq NM of which about 87% is deeper than 300m. The tertiary area is approximately 40 Sq NM of which about 78% is deeper than 300m.

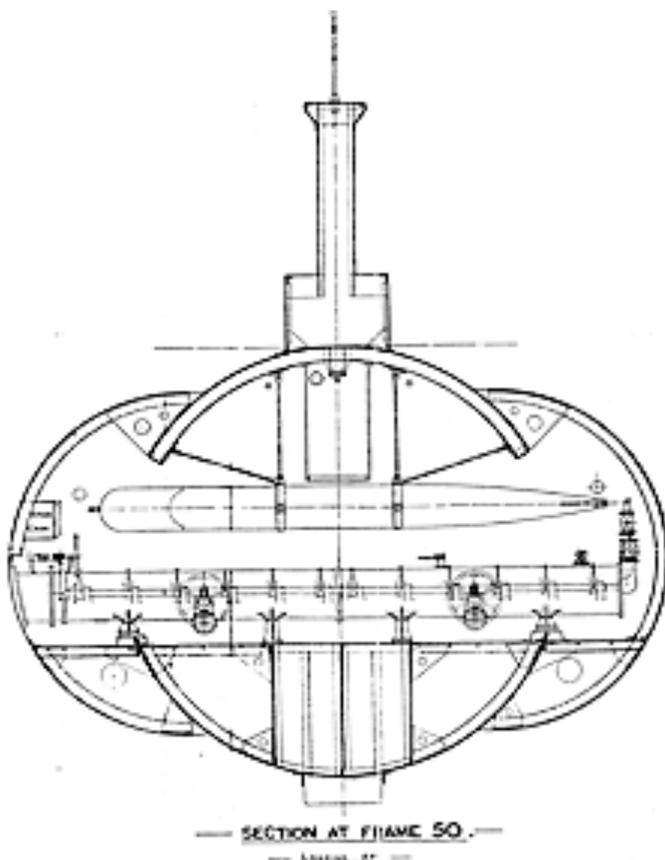
Figure 4 Cross section at Frame 50

The construction of the pressure hull around the beam torpedo tubes is of interest in the beam on grounding scenario, where the outer end of the tube or the pressure hull annulus constructed to accommodate the tubes may be struck. The athwartships bulkhead forming the bulge to accommodate the broadside tube comes out from the pressure hull at frame #54, to the line formed by saddle tank skin, where there is a right angled seam, the bulge then follows the outer line of the saddle tank for 6 frames ($6 \times 21" = 126"$ (3.95m) before another seam joins it to the after athwartships bulkhead at frame #48 (frames were numbered from aft). Scantlings and plating appear to be as for pressure hull - as one would expect; it is the pressure hull.

Overall, the broadside tubes would appear to be a source of strength, rigidity and support to the outer plating of the 'saddle tanks', rather than vulnerability. However, the forward corner/seam of the pressure hull annulus built to accommodate the tubes would be vulnerable as its shape could provide a single point to absorb the force of the grounding focusing these forces on a point of the pressure hull, if this were to fail then the pressure hull would be breached.

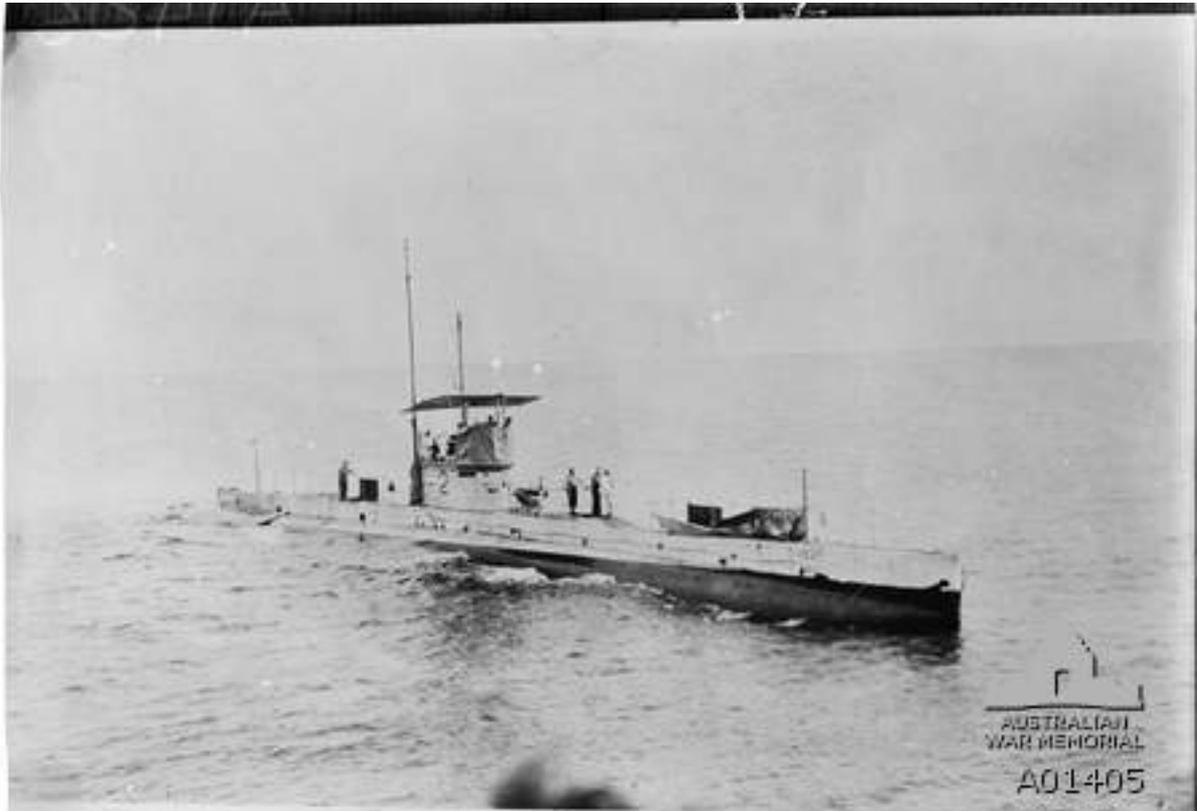
Figure 5 — AE2 Enroute Australia with WT and Signal Mast raised, no aerials rigged AWM 01405,

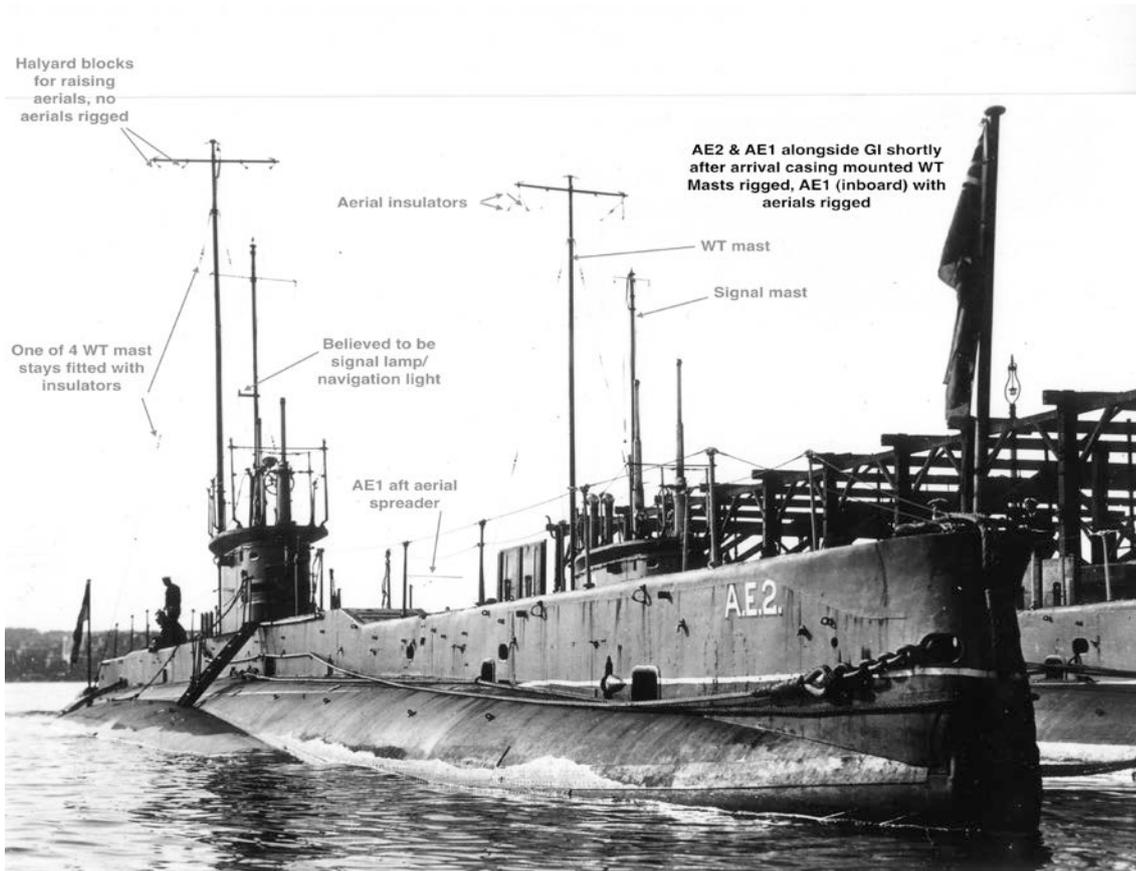
AWM H11559

Figure 6 – AE2 & AE1 alongside at Garden Island with WT and Signal masts rigged in the ‘as built’ configuration

- AWM photo H11559 taken at Garden Island after arrival in Sydney shows the WT mast and wire stays and aerial post on the fore casing.
- AE2's aerials are not rigged, AE1 is inboard and her after aerials, including the after spreader are visible (see description below).

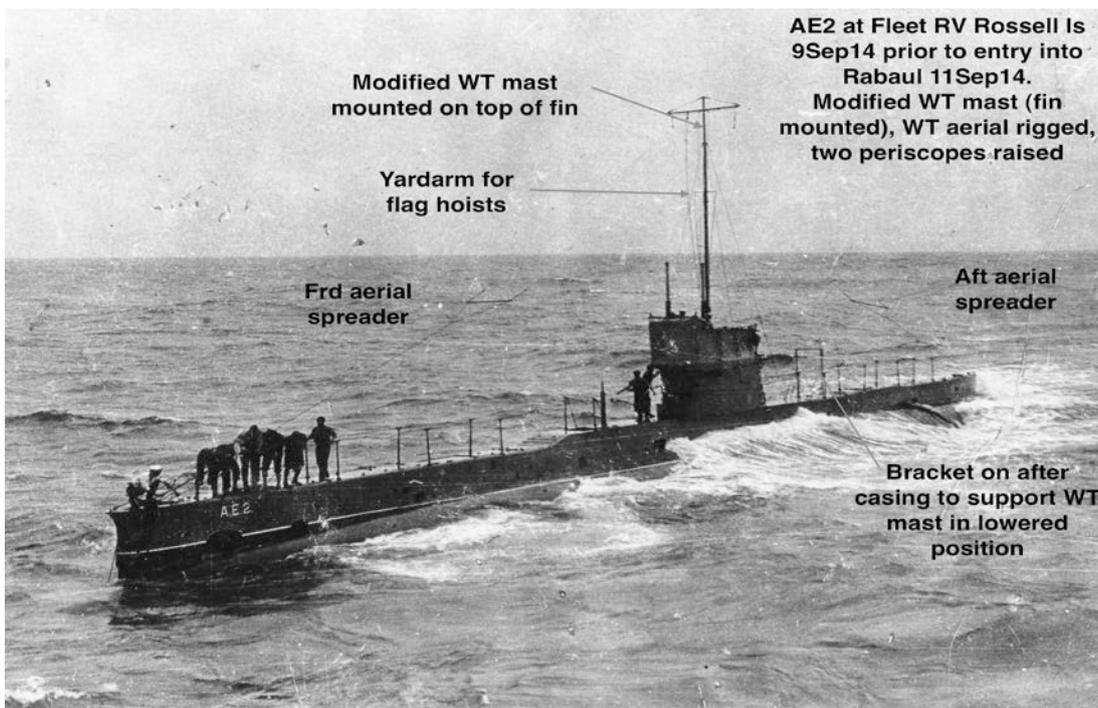
Figure 7 AE2 9th September 1914, on passage to Rabaul, WT mast rigged from top of fin AWM A01939

3.6.1.6 Photographs of AE1 and AE2 taken after the docking in Fitzroy Dock 3-24th June 1914 and during the PNG deployment indicate that the WT mast arrangements in both submarines were modified, perhaps during the docking:

- x The WT mast was moved to the top of the fin, displacing the signal mast.
- x This allowed the mast to be hinged and lowered along the top of the fin, supported by a bracket on the after casing prior diving, rather than unrigging and stowing it.
- x It was fitted with a yardarm for flag hoists. This function was previously carried out by the signal mast (see para 3.6.2 below).
- x The all-round white light mounted on the signal mast, used as part of the navigation lights and for signalling was relocated to the new mast.
- x The aerial arrangements appear to have been simplified to a single span on each side of the yardarm, hauled up by halyards fitted to the WT mast.
- x The spreaders were led straight to strong points on the forward and after casing, dispensing with the aerial posts on both casings.

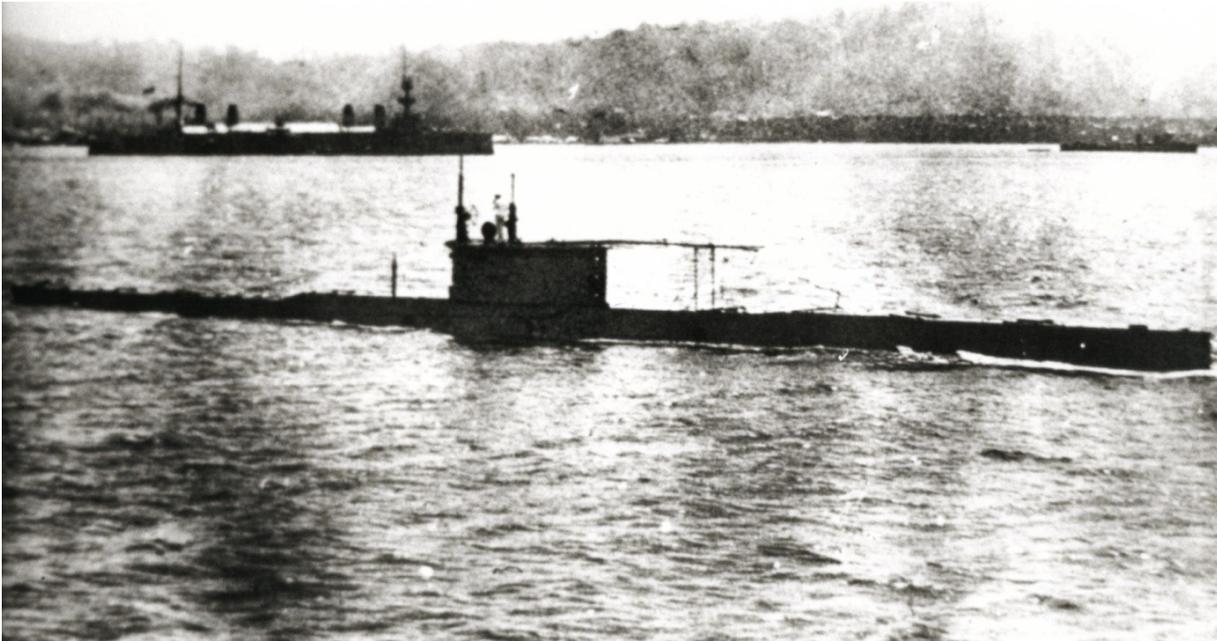
AWM A01404

Figure 8 — AE2 Entering Rabaul Harbour September 1914, WT mast stowed on top of fin and supporting bracket on after casing.

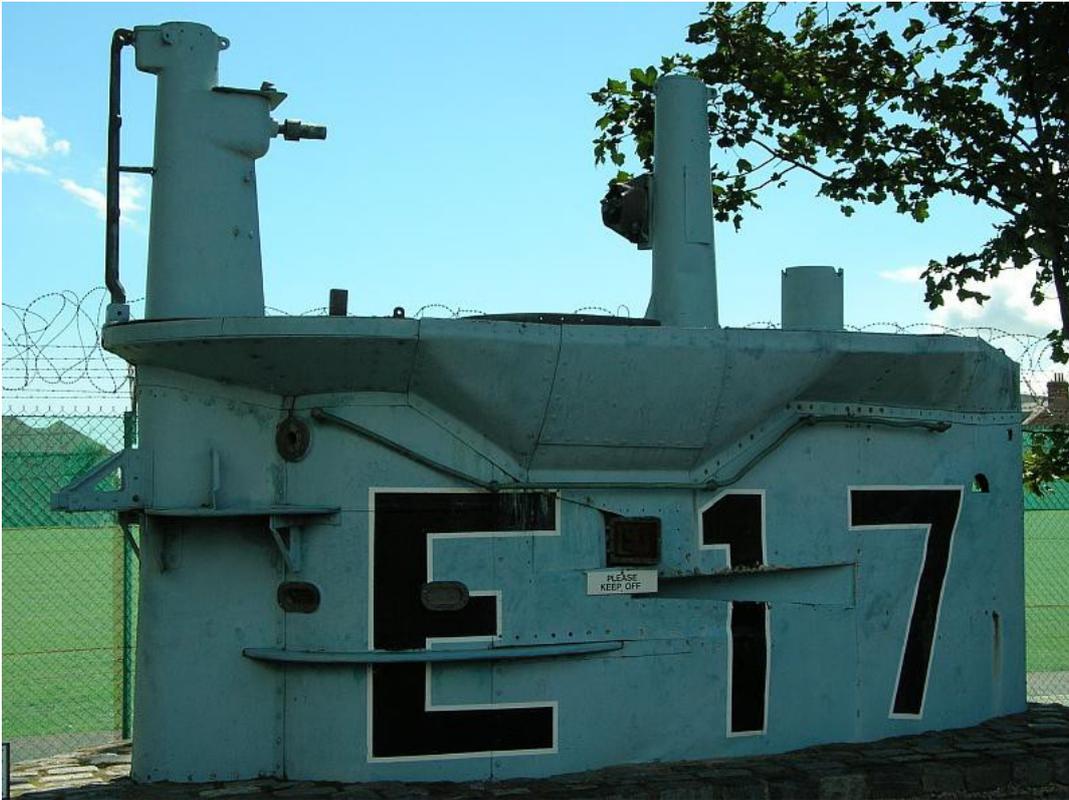
Figure 10 Fin of E17 at RN Submarine Museum, Gosport

Note, the two upright tubes on top of the conning tower are the periscope standards; the forward (left hand) standard also houses the arrangements for the upper steering wheel.

The periscopes were supported by individual periscope standard, heavy, cast tubes bolted to the top of the conning tower. This photo of E17's fin [below] illustrates these, (note there were differences in the layout of the conning tower between AE1 and E17):

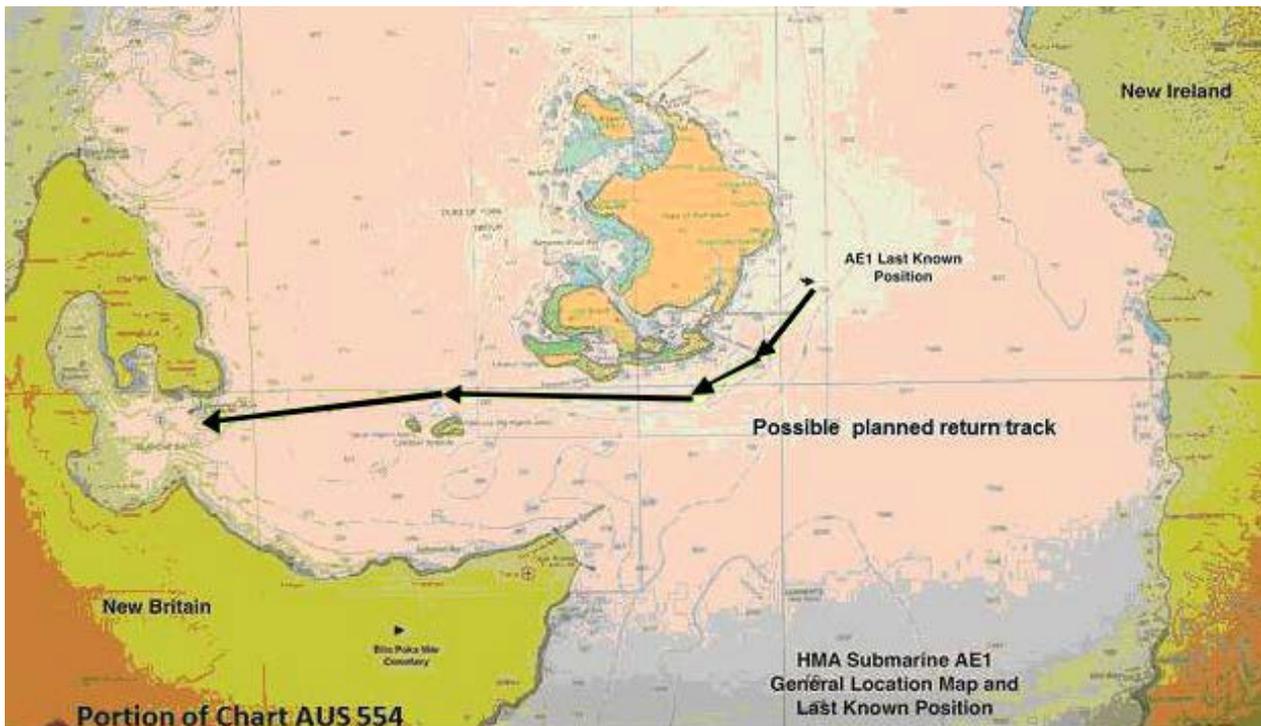
Figure 17 General Location Chart

David Nicholls' General Operations Plot reconstruction above, details the geography and relevant environmental data.

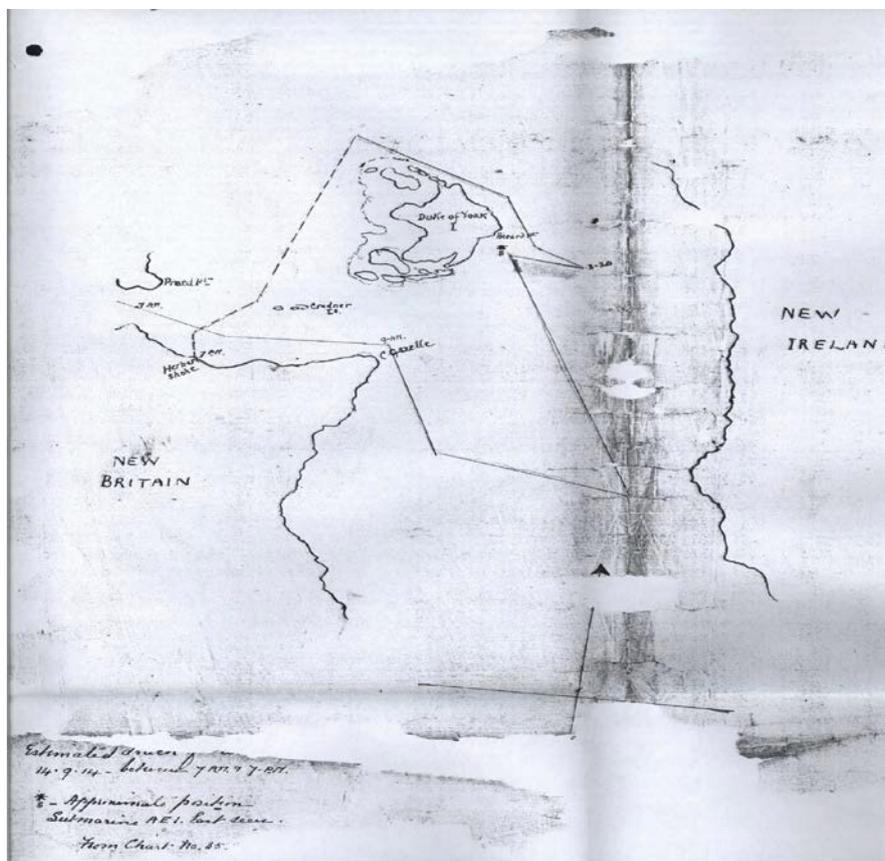
The tracing of the chart attached to LEUT Warren's Report of Proceedings of HMAS PARRAMATTA on Monday 14th September 1914 provides the only firsthand record of AE1's 'last sighted' position.

This tracing is a reconstruction, rather than a precisely plotted position based on fixing both PARRAMATTA and AE1 simultaneously.

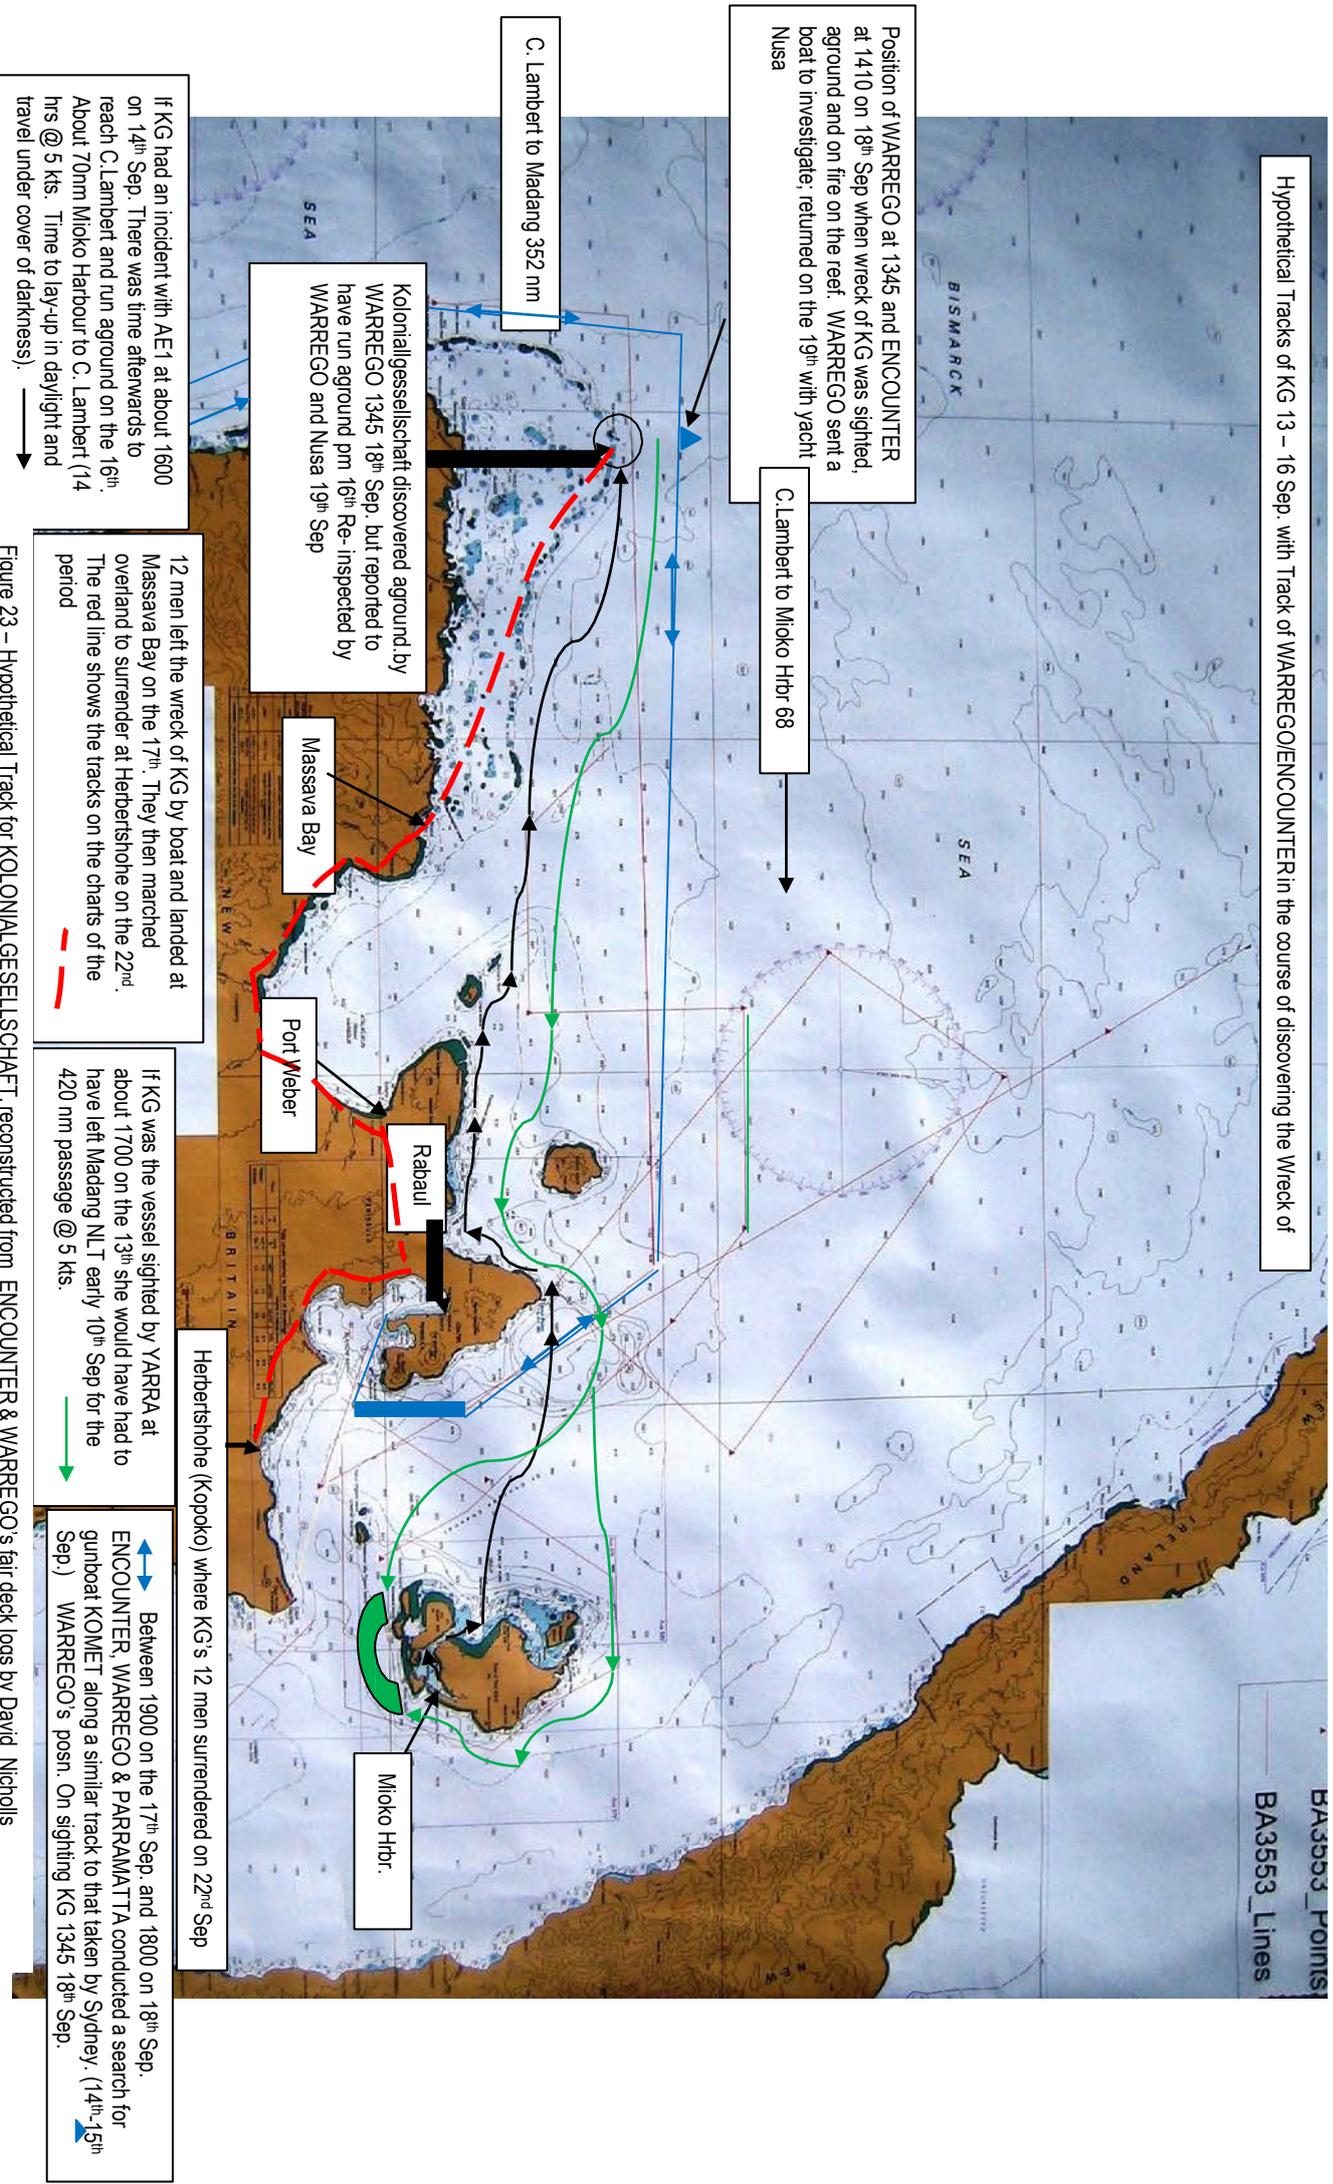
Hypothetical Tracks of KG 13 – 16 Sep. with Track of WARREGO/ENCOUNTER in the course of discovering the Wreck of

Figure 23 – Hypothetical Track for KOLONIALGESELLSCHAFT, reconstructed from ENCOUNTER & WARREGO's fair deck logs by David Nicholls

beacon...) marked on the modern chart. The reconstruction under by CMDR David Nicolls RAN Rtd summarises the situation.. Based on this reconstruction it would appear that KOLONIALGESELLSCHAFT grounded on outer edge of the northern extremity of the reefs to the north of Cape Lambert, close to a 13.5 m (42 ft) high beacon marking the extremity of the reef. The grounding is most likely to have occurred at night, as by day it would be very difficult to miss seeing the beacon. This Report is specific that only one used cartridge case was found – contrary to some of the diary accounts of multiple cartridge cases. Nothing turns on the number of fired cartridge cases, as even one shot through the pressure hull would have been sufficient to put the AE1 at grave risk.

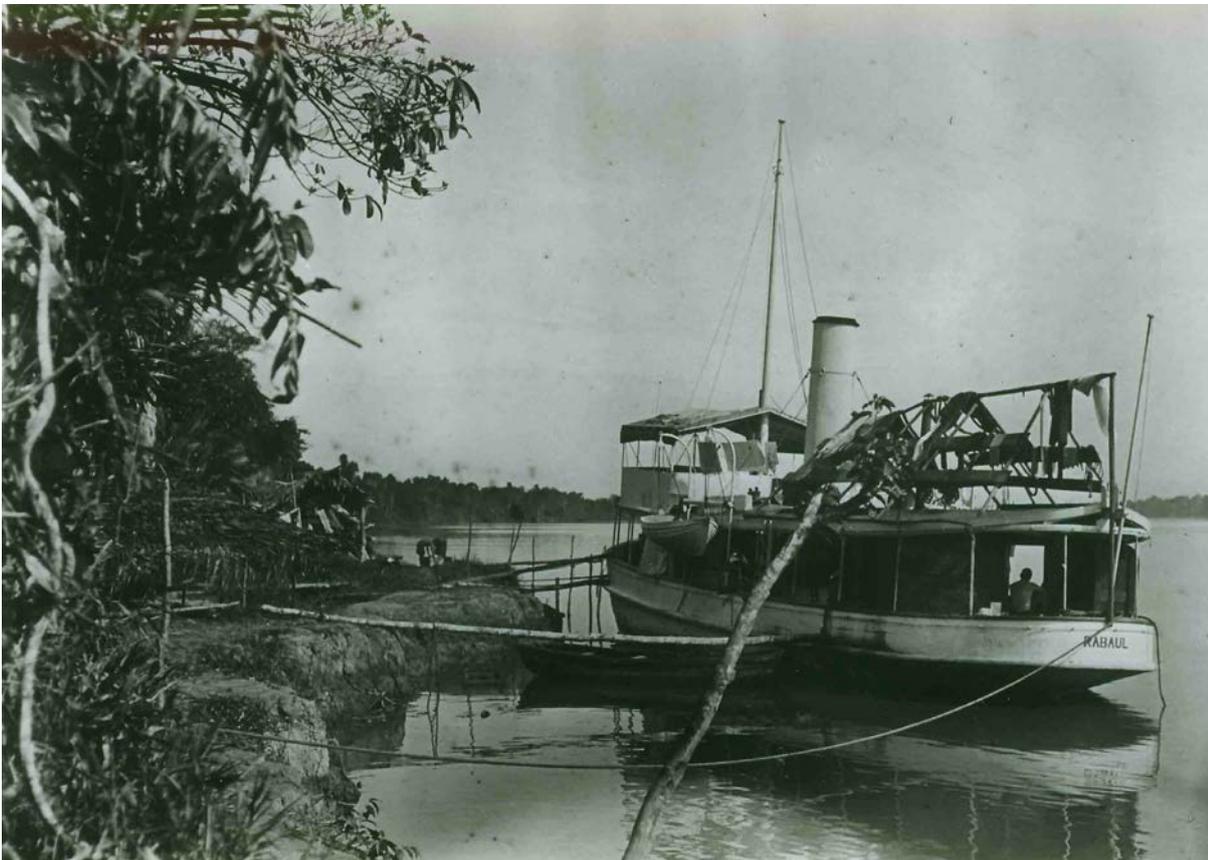
John Foster's research indicates that the KOLONIALGESELLSCHAFT was built for a German expedition up the Sepik River, led by Dr Behrman of Madang. Once the expedition was completed KOLONIALGESELLSCHAFT was handed over to Dr Gebhardt, the District Officer at Madang for use as a patrol boat. The KOLONIALGESELLSCHAFT's Certificate of Survey⁵⁸ issued at Hong Kong on 19th January 12 states that she was single screw steamship built in 1911 in Hong Kong by Ulderup & Schluter for the German Government. She had a single, 180-psi boiler driving a triple expansion engine manufactured by the builders, of 125-horse power. The ship was built from wood, with hardwood frames, teak planking, reinforced by three steel bulkheads, giving a gross tonnage of 73.3 tons. Michael Rikard-Bell estimates that she would have had a loaded displacement of 153 tons (169 tonnes) and a draft of 4' 3" (1.3m).

Figure 25 –KOLONIALGESELLSCHAFT at Karajundo, 20th July 1913 – Exploration of the Sepik River

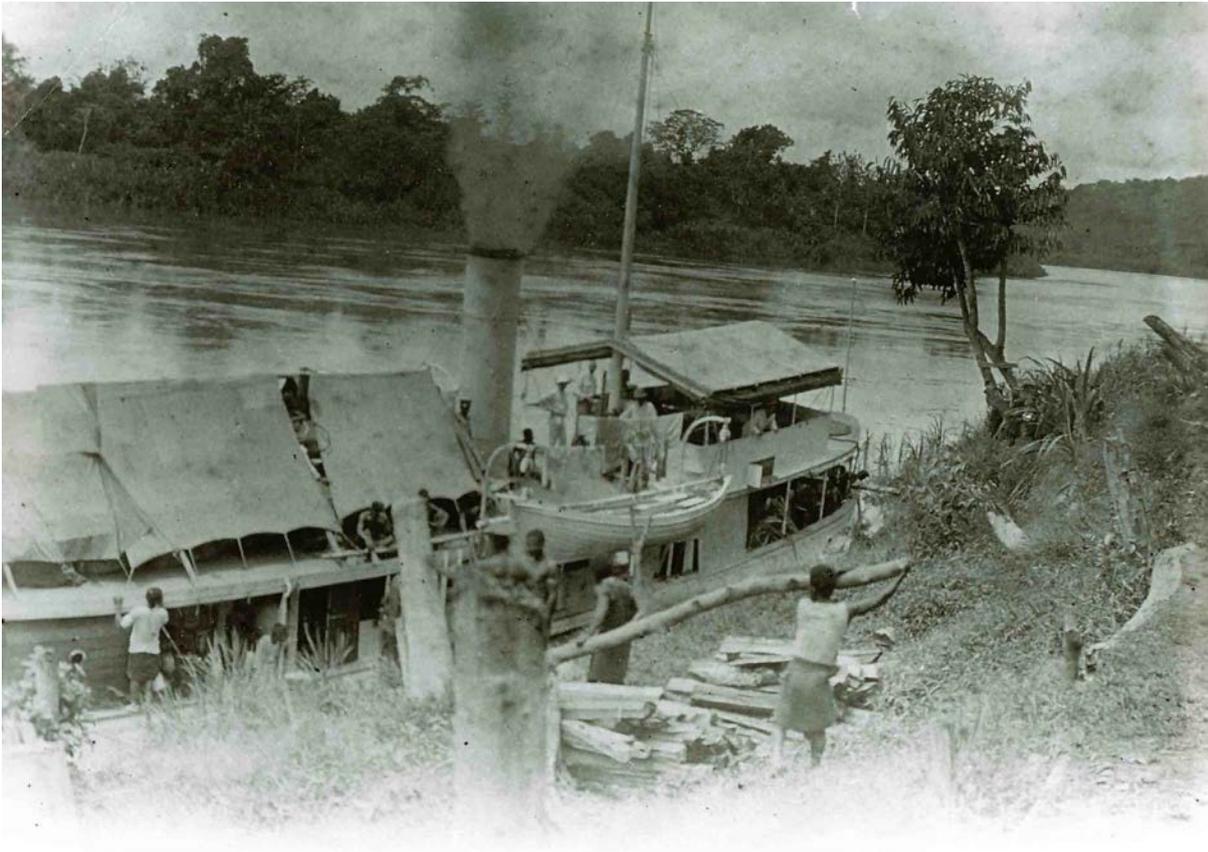
Figure 26 - KOLONIALGESELLSCHAFT, Exploration of the Sepik River, Malu, 20th September 1913
Source:-Peter Richardson from the Bundesarchiv Dr. Thurnwald Photo Collection

It seems likely that the boiler was wood fired, since coal would not be available on the Sepik River. This assumption is supported by the baulks of timber apparently being loaded onboard in Figure 26. Wood is not as effective as coal as a fuel and this would have reduced her performance. Further, Michael Rikard-Bell observes that the ship was probably not fitted with a condenser, discharging spent steam rather than recycling it and hence requiring to refill with fresh water for boiler feed at regular intervals. This would not be a problem on a freshwater river but would be an issue at sea. Overall it is assessed that KOLONIALGESELLSCHAFT had only limited sea-keeping ability.

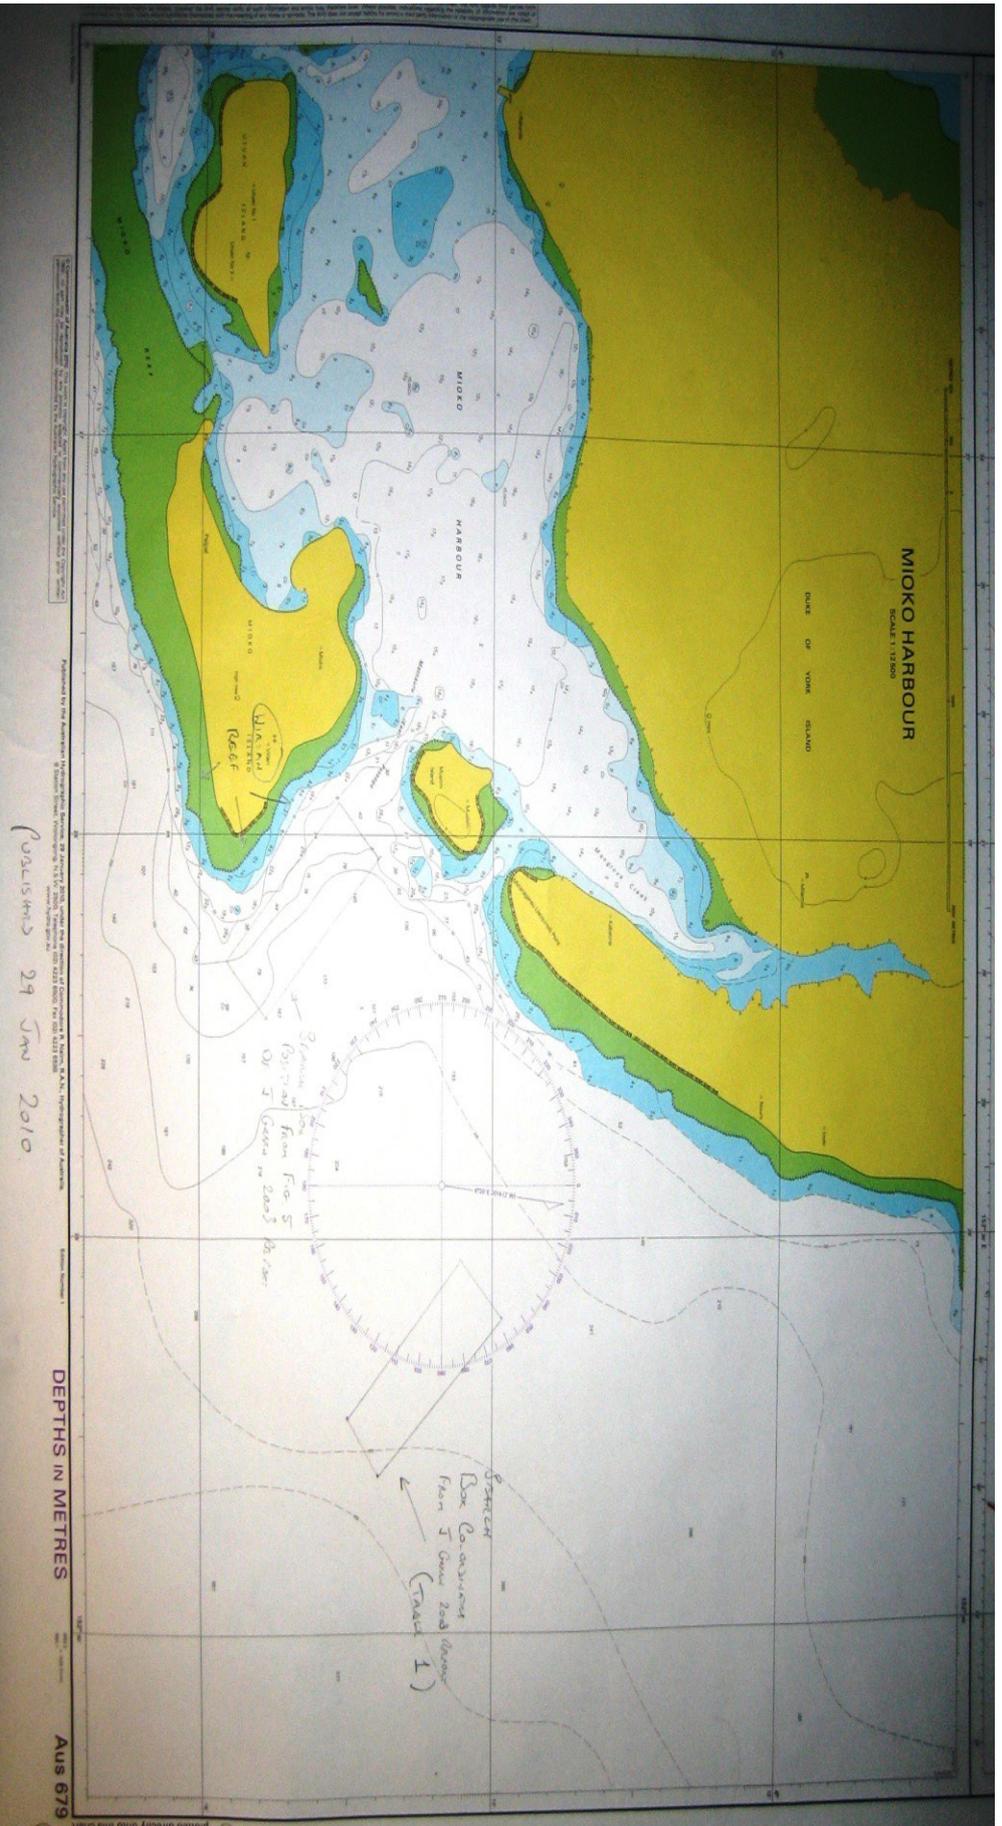
Figure 27 — Modern Chart of The Entrance To Mioko Harbour Showing Wirian Reef off The Eastern End of Mioko Island
Australian Hydrographic Office Chart

This would indeed be a formidable and dangerous spot for AE1 to venture into – if indeed, that is what she did!

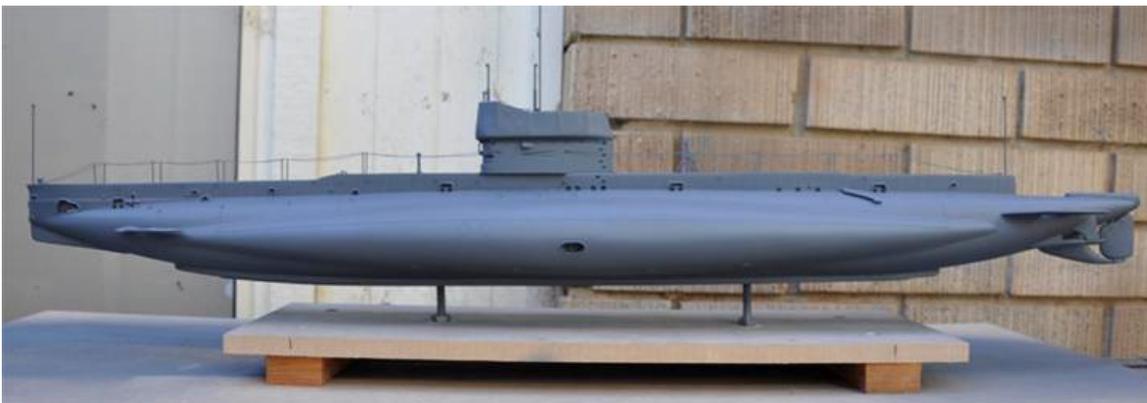
- x The forward part of an E boat's pressure hull likely to be impacted in the event of a heavy grounding by the bows is particularly strongly constructed (in anticipation of this scenario), with a strong fore foot at the bow and an enormously strong keel section further aft; the keel does not start for some 21.5 ft (6.5m) aft of the bow and extends aft for 120 ft (36.5m). The arrangements of the fore foot and keel are illustrated in this scale model.

Figure 28 — Scale Model of AE1, Port Beam Aspect

- x The internal tanks that would be exposed should the pressure hull forward of the keel be breached in such a grounding are (from the bow moving aft):
 - o Forward Compensating Tank.
 - o Forward Trim Tank.
 - o Magazine.
- x No 1 Oil Fuel Tank (OFT) starts 26 ft (9.9m) back from the bow and is protected by the

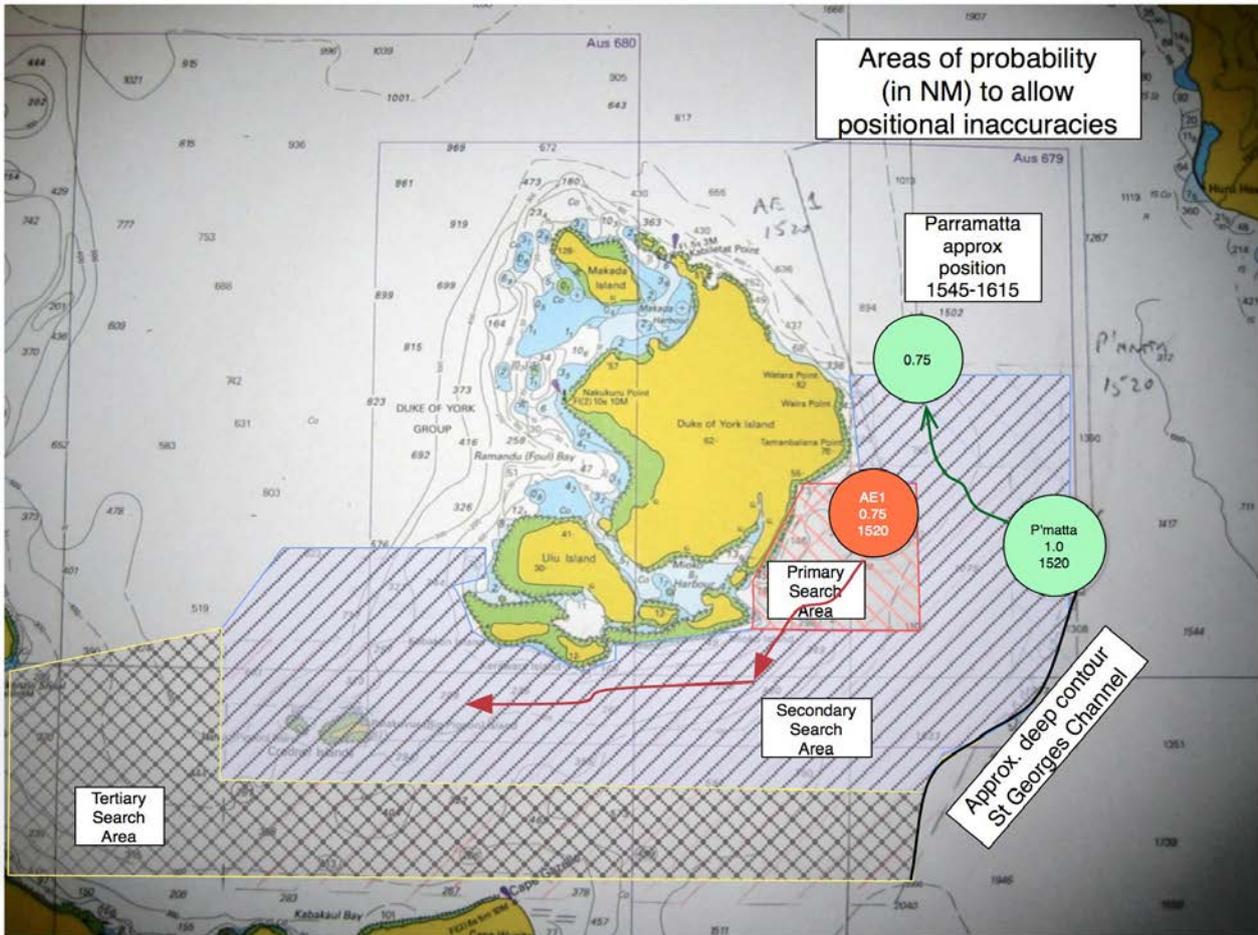
Figure 30 Recommended Search Areas

As defined above, the tertiary search area should encompass the approaches to Simpson Harbour along the track of the most direct route back to harbour. The tertiary area is approximately 40 Sq NM of which about 78% is deeper than 300m
