HMAS AE1

**Main Report –
Finding the Men
of AE1 –
20 December
2017**

**Version 2
November 2018**

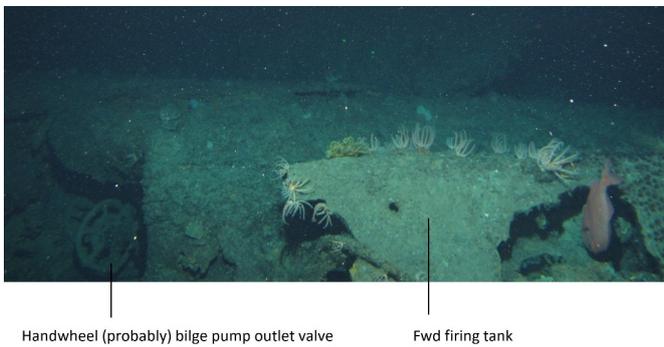
Figure 5 - Handwheel & Forward Torpedo Tube Firing Tank (Bow is to the right)

- Port and starboard forward hydroplanes with sheared-off plane guards lying on seabed.
- Forward hydroplanes are set to rise.
- The pale item on the casing is what remains of the badly corroded fwd firing tank.
- A shadowed lip edge of the crushed pressure hull.
- Valve handwheel, probably the bilge pump outlet. E-class had no handwheels outside of the pressure hull hence this is clear evidence that the pressure hull has been crushed.
- Debris lying aft of the handwheel is probably the remains of the casing and pressure hull.

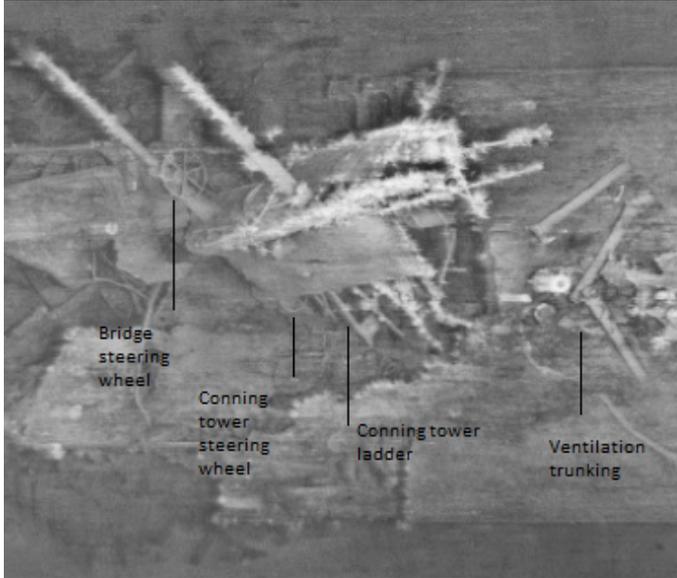
Figure 6 - Fin Area (A)

- Conning tower upper hatch shut.
- Bridge wheel is in place (not stowed in conning tower).
- WT antenna stump is intact (appears foreshortened by camera angle).
- Guardrail stanchions folded flat for diving.
- Forward periscope is fully raised.
- After periscope appears raised but is not in a fully raised position – probably the consequence of the lifted fin.

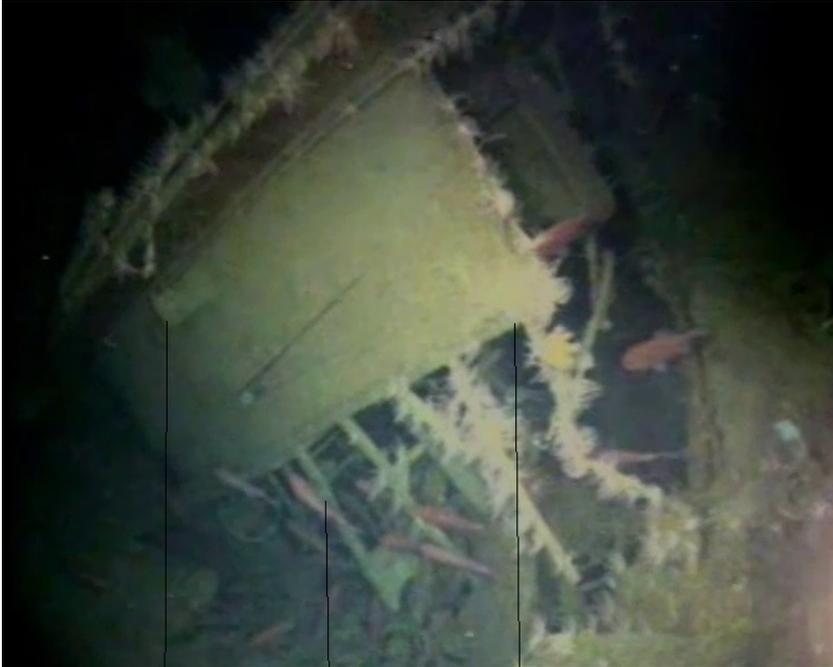
Figure 9 - Fin Area (D)

Port navigation light

Conning tower ladder

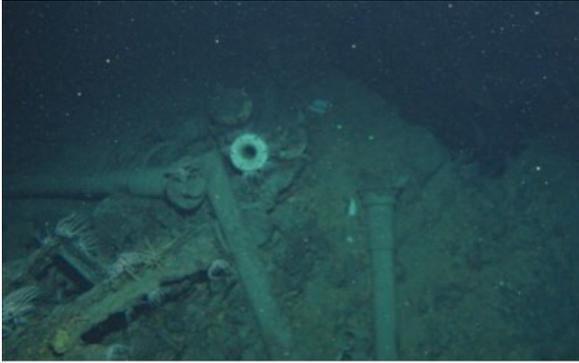
Figure 10 - Ventilation System Pipework

4.3 Notes – Figure 10

- Shows three (of five) ventilation trunks.
- Trunks have been exposed (and dislodged) by lifting of the fin.
- The two (dull) circular shapes are ventilation sluice valve flanges.
- The (brighter) flange has (probably) been exposed following one trunk being wrenched off its sluice valve connection.

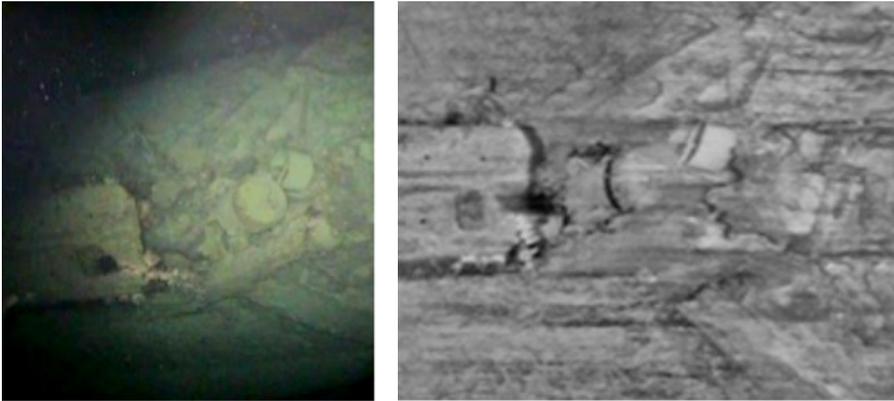
Figure 13 - Exhaust Tank Outlet Pipework

4.6 Notes – Figure 13

- Exhaust tank outlet pipework debris remains while the overboard sections are missing.

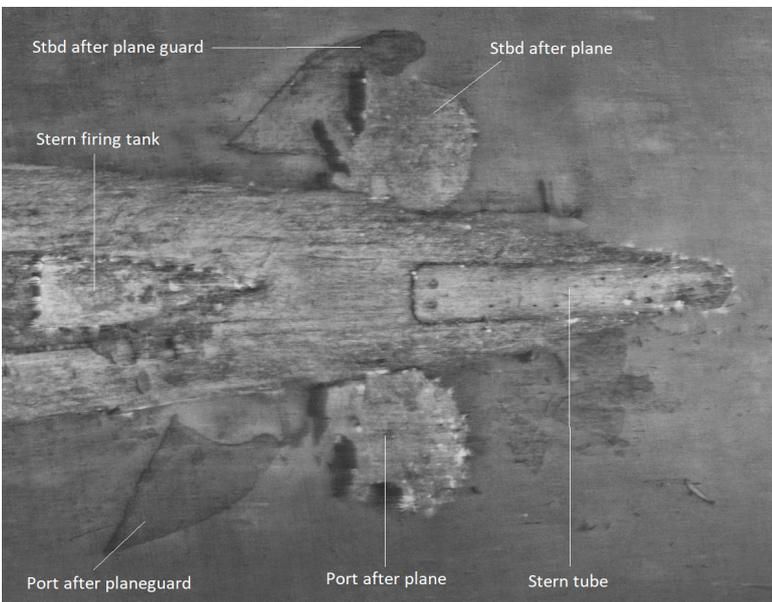
Figure 14 - Stern Section

Figure 15 - Stern Firing Tank & Port After Hydroplane

4.7 Notes – Figures 14 & 15

- Different angles and positions of after hydroplane guards relative to their original positions.
- Effects of erosion/corrosion on the forward edges of the after planes.

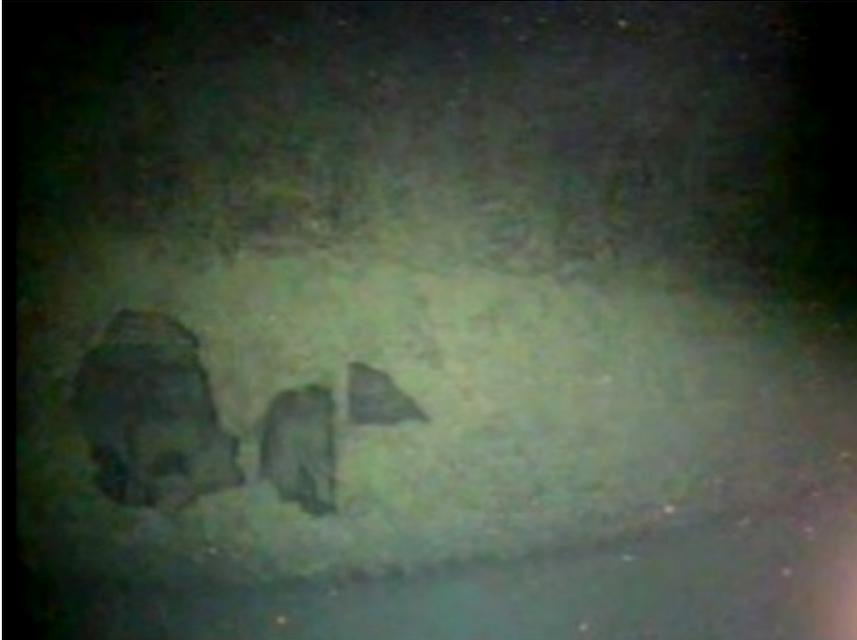
Figure 17 - Nos 6 & 8 Main Ballast Tanks

4.8 Notes – Figure 16

- Comparatively little deterioration of these Main Ballast Tanks compared with all others.

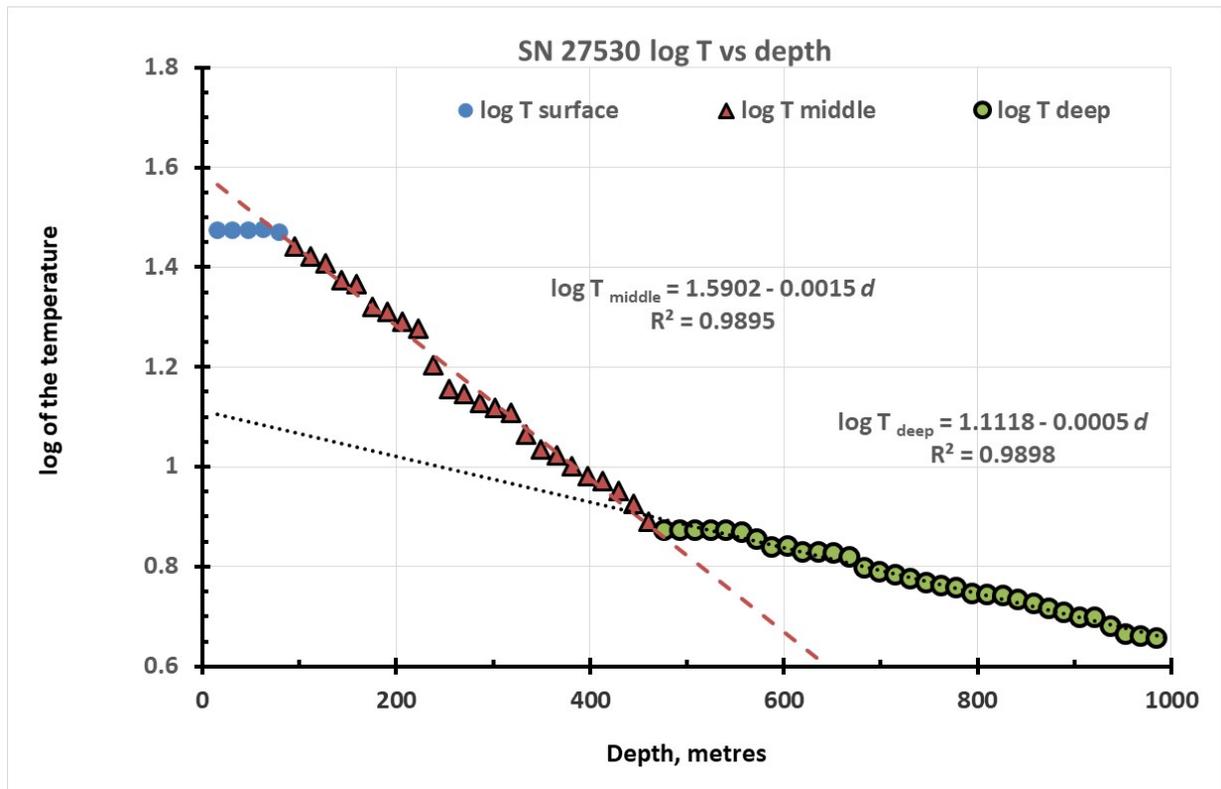
Figure 1 - Typical Plot of the Temperature Profiles with Depth in the Waters adjacent to the AE1 Wreck

A representation of the logarithmic fall in temperatures is seen in Figure 1, where the surface temperatures are essentially constant for the first 60 metres and then the temperature begins to fall in a logarithmic fashion to 470 metres, but from that point there is a slowing down of the rate at which the temperature falls, by a factor of three times (see Table 1).

Since the mean temperature of *AE1* is going to vary over time, because of seasonal variations, the present data provides a good indication what the actual temperature on the site is likely to be i.e. around 11.6 °C.

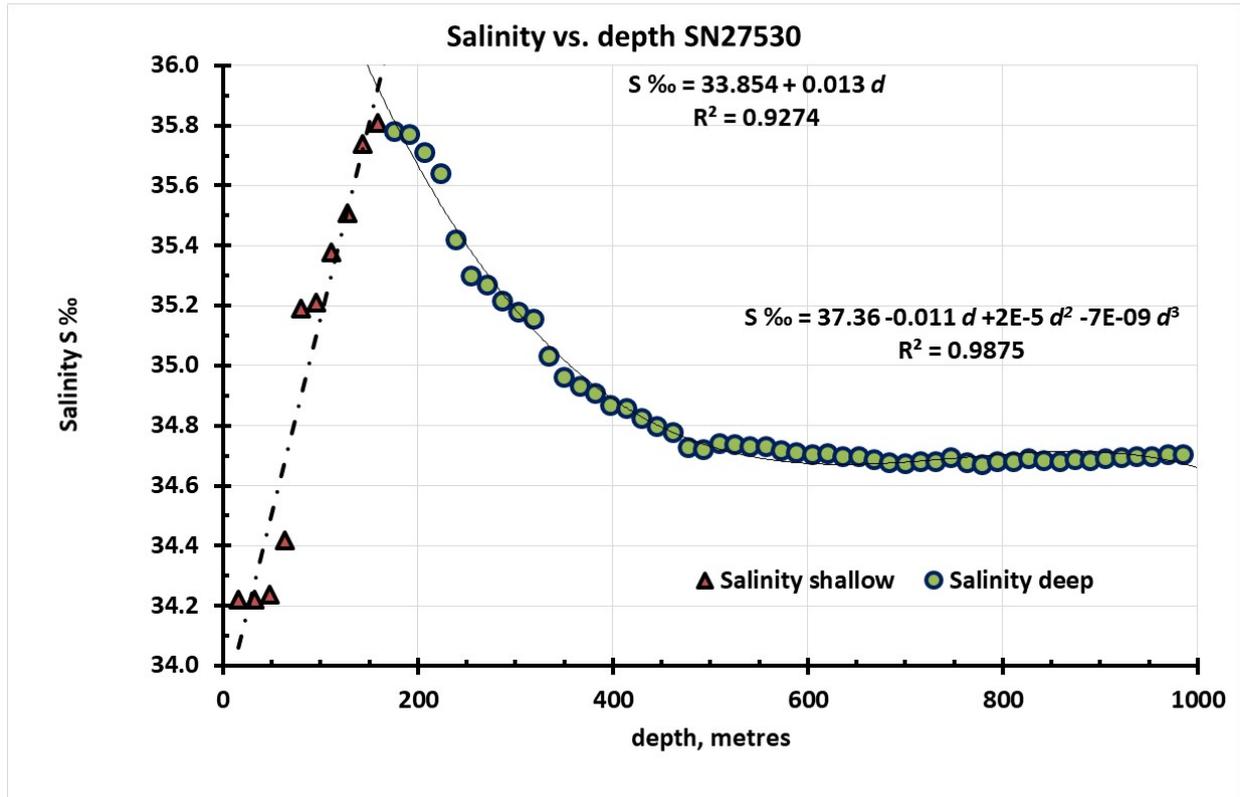
Figure 2 - Plot of the Variations with Water Depth with both Linear & Cubic Relationships

The salinity profiles showed more complex behaviour in that both sensors showed a linear increase in salinity for the first 160 metres and from that point onwards, the salinity regularly fell with increasing depth, as shown in Figure 2. The data from the regression analyses (Table 1) showed that the period of increasing salinity with depth varied from $+0.0149 \pm 0.0018$ ‰/metre to 0.0129 ± 0.0013 ‰/metre which is consistent with the view that the two sensors showed the same rate of temperature increase with water depth, since the difference in the two slopes is not greater than the sum of the standard deviations of the slopes (i.e. $0.002 < 0.0031$). The intercept values for the sensors were 33.85 ± 0.17 ‰ and 33.79 ± 0.13 ‰. The two linear regressions give intercept, or starting points at surface waters, which are within 0.06 ppt of each other and since the sum of the standard deviations of the values is 0.30 shows that the different intercept values are statistically indistinguishable from each other, as would be expected from analyses carried out at the same time and same day on the same site.

Since the principal aim of the measurement of the properties of the water column was to determine the conditions on the AE1 wreck site, the Excel cubic equation for the changes in salinity between 160-1,000 metres can be used to get an estimate of the salinity at the 350-metre depth. The cubic equations from both instruments gave a mean value of 35.04 ± 0.84 ‰ which gives, when combined with the calculated temperature of 11.6 °C gives a maximum dissolved oxygen content of 8.75 ppm.

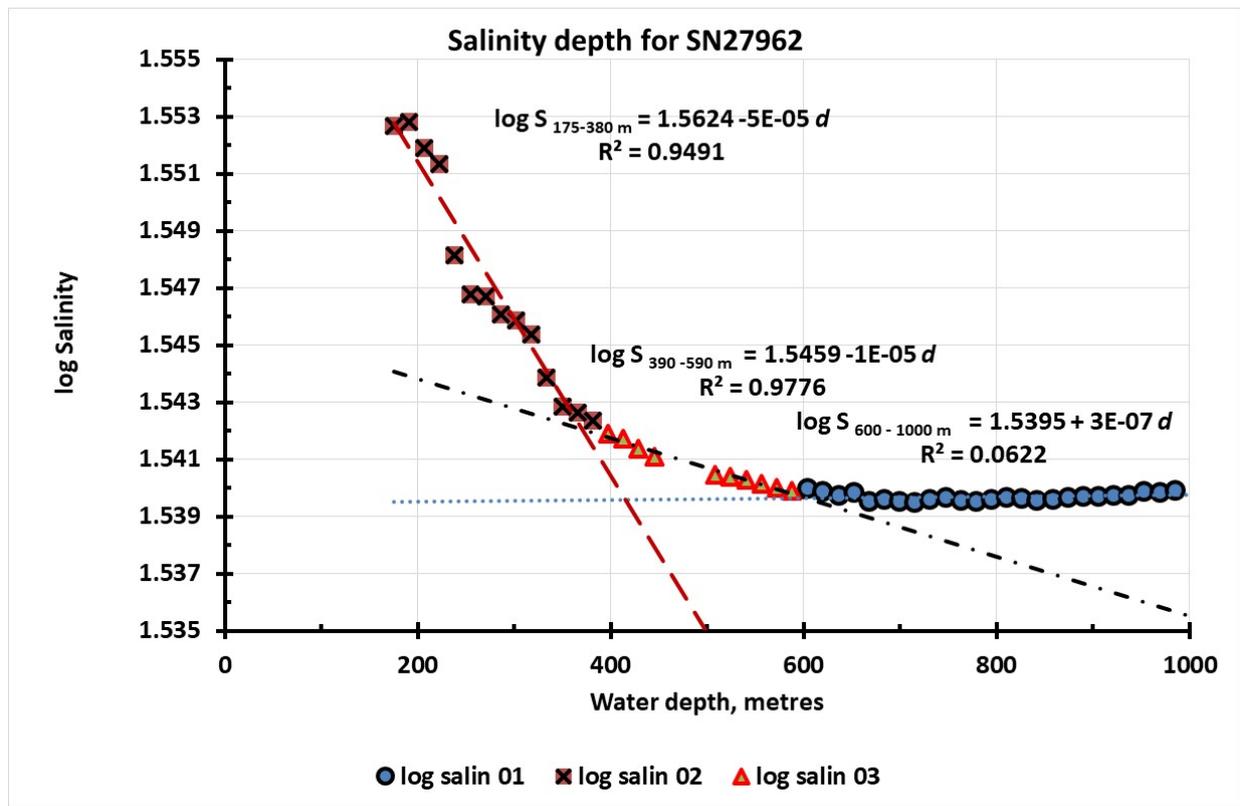
Figure 3 - Logarithmic dependence of salinity on water depth from 175-1,000 metres

A more detailed analysis of the decreasing salinity showed that rather than being a continuous function, the fall in salinity with depth was a logarithmic function i.e. it showed the same dependent parameter that the temperature did. A summary of the linear regression analyses of the logarithmic dependence on depth of the salinity is shown in Table 3 and in Figure 3. With the salinity data there was more of a divergence in the two sets of results, with somewhat different “turning points” in the log salinity vs. depth profiles which were subject to interpretation by the author of this report. The upper regions, beyond the initial linear increases in salinity as the dilution factor of the fresh water run off was overcome and the underlying salinity demonstrated its presence, showed a systematic fall in the log of the salinity with increasing depth. Both sensors gave a common range between 175 to 380 metres before the rate of

Inspection of the data in Table 3 shows that both sensors give the same intercept values for the log-salinity versus depth linear relationships, which indicates that part of the “error” associated with the different turning points is due to the choice of which data points should be included in any given linear regression.
