**OPERATION SILENT ANZAC**

**INTERIM REPORT ON THE MARITIME  
ARCHAEOLOGICAL ASSESSMENT 2014**

**HMAS AE2**

## Project Silent Anzac Maritime Archaeological Assessment 2014 Interim Report

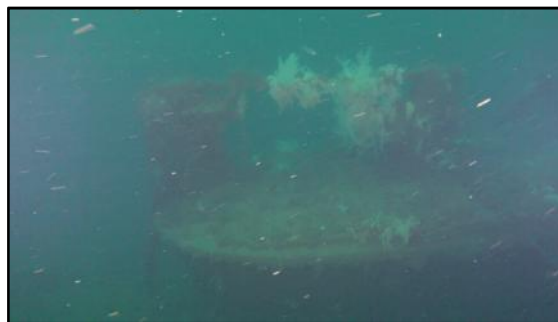
Figure 8 First view of AE2 fin

The ROV completed an external survey; good imagery was obtained and no major changes to AE2's appearance from the 2007 and 2013 surveys were noted. A diving medical emergency evacuation exercise was held, followed by a dive to clear away debris from around the hatch to avoid this entering the submarine during future serials.

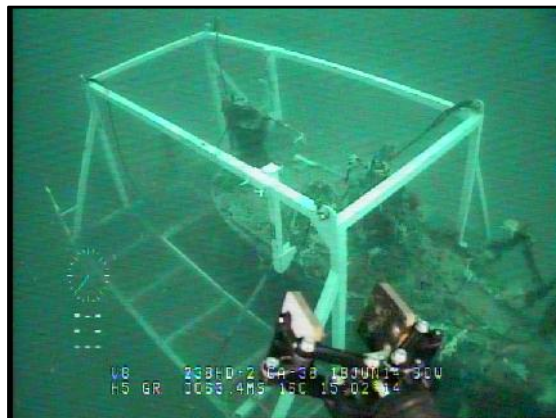
**Figure 10 DSP in position. Taken on final flyover, shows CP connections in place with ROV grabber in foreground.**

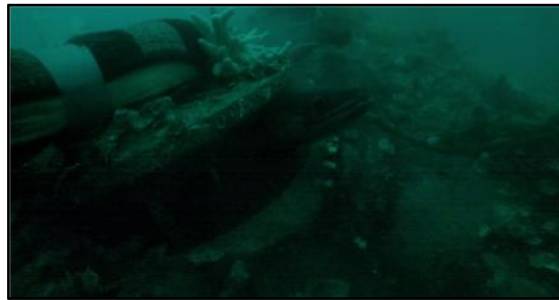
Figure 12 Bunts the conger eel emerges

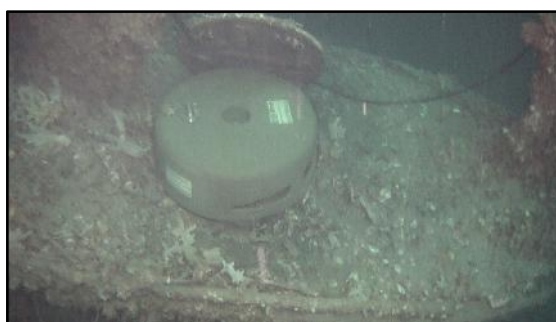
Figure 19 Hatch closure (Top Hat) in place, DSP removed. Anode connection cable visible

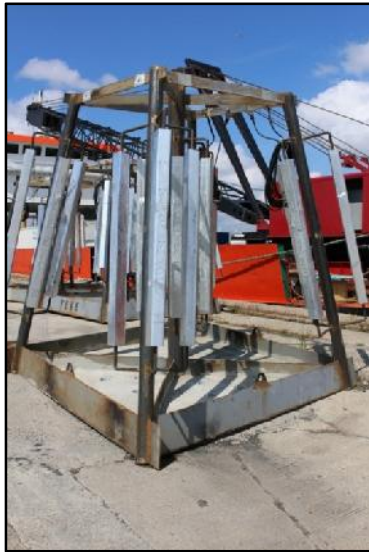
Figure 2. Steel support structure for a 17 anode pod.

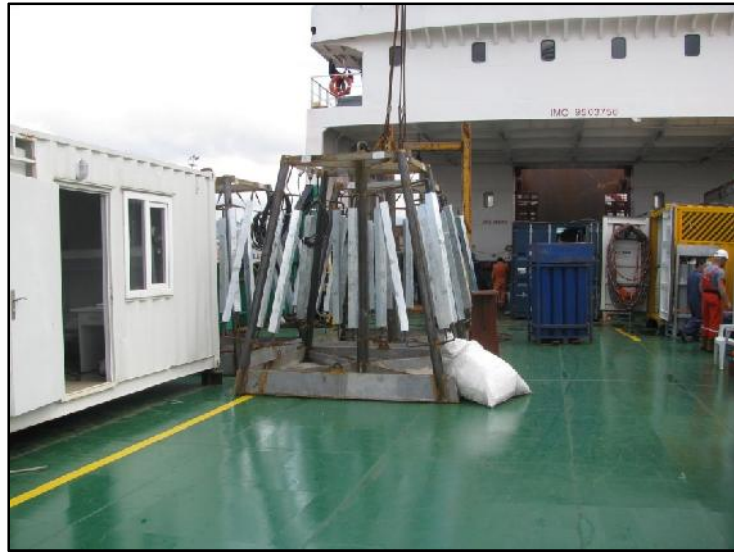
Figure 3: The three anode pods assembled on the deck of the dive support vessel.

Three clumps of anodes were constructed, the details of which are shown in the attached drawing that formed the basis of the tender let by the AE2CF for their construction. The anodes can be seen in Figures 2 and 3. It should be noted that this work represents the largest in-situ conservation project ever attempted on an historic iron shipwreck. Previous work by the author of this Annexe has resulted in successful in-situ treatment of guns, anchors and a marine steam engine through use of anodes to remove the chloride ions and to eliminate the high acidity microenvironment underneath the concretion. It is this environment that promotes corrosion of iron in the presence of chloride ions.

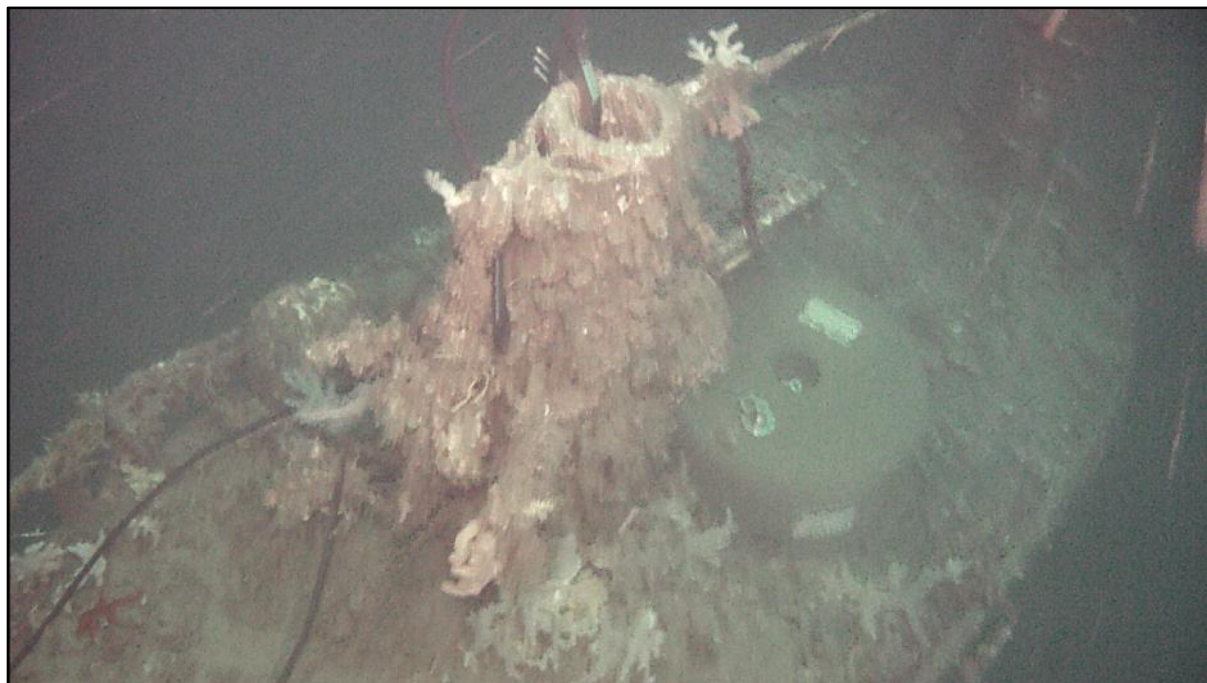
Figure 4: Clamp and cable arrangements for central anode pod connection to the conning tower.

The drop in voltage demonstrates that the attachment methods have worked and that the cathodic protection system is functioning as it was designed to. The initial measurement of the area adjacent to the conning tower hatch cover provides the baseline for demonstrating that the anodes are working as this section of the vessel has been naturally cathodically protected by the reactive iron to which it was originally attached, so any voltage decrease proves that cathodic current is flowing into the shipwreck. The logarithmic fall of the  $E_{\text{corr}}$  with time is consistent with the establishment of the cathodic protection system as the anodes become activated as they respond, through the attached cables, to the difference in the voltage of the corroded submarine and the zinc blocks. The regression analysis of the line of best fit of the  $E_{\text{corr}}$  data with the log of the attachment time had an  $R^2$  of 0.9648 (a  $R^2$  of 1.0 is a perfect fit to the straight line) with an associated equation,

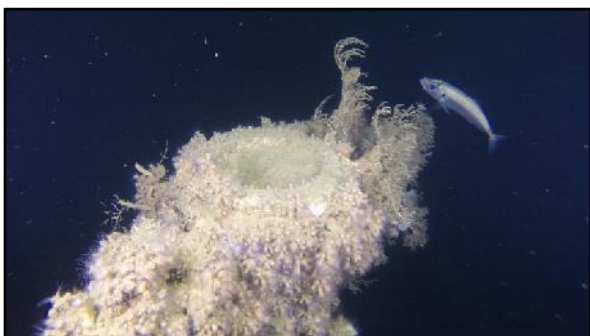
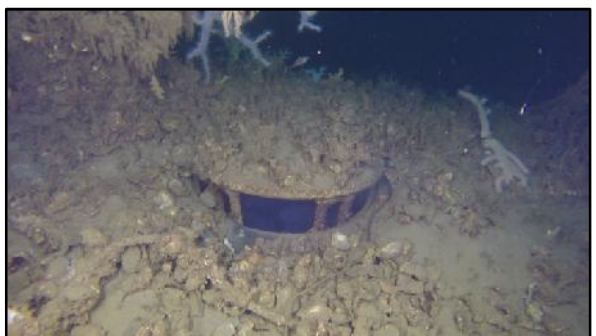
Figure 4 Forward Periscope pedestal and Conning Tower Hatch

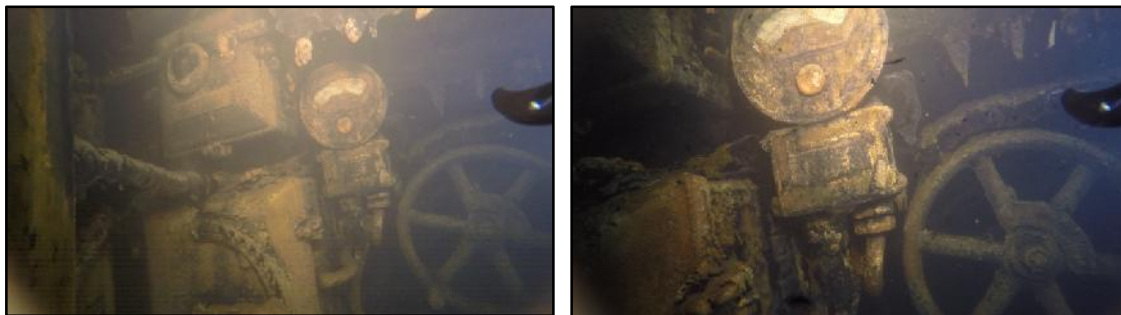
Figure 11 Ballast Pump Starter, operating handwheels and gauges plus detail

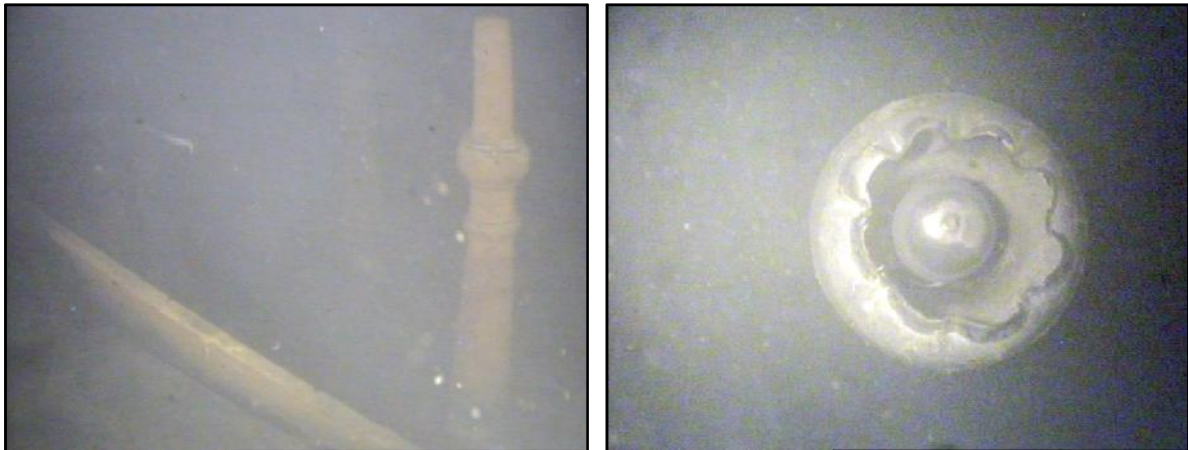
Figure 14 Wardroom table (upside down); Captain's Desk Light

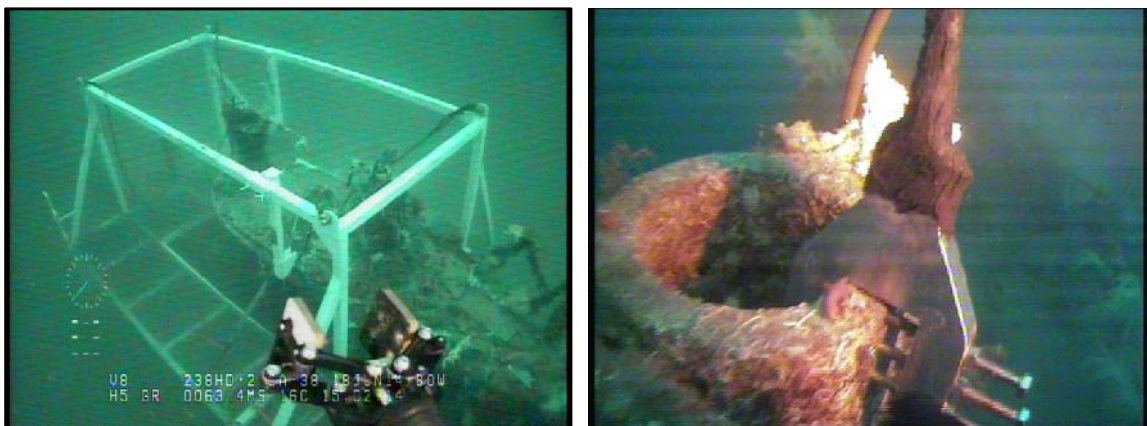
Figure 15 DSP Prior to Removal; Midships (Periscope Pedestal) CPS connection

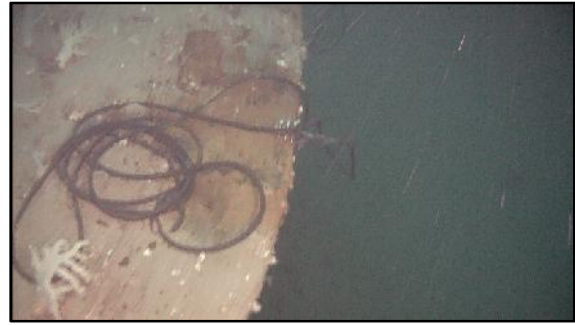
Figure 16 Forward (Windlass) and After (Port Hydroplane) CPS Connections

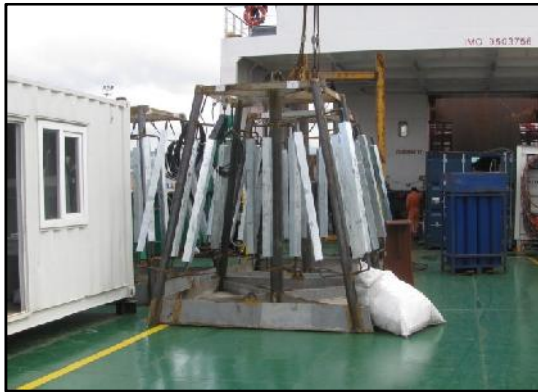
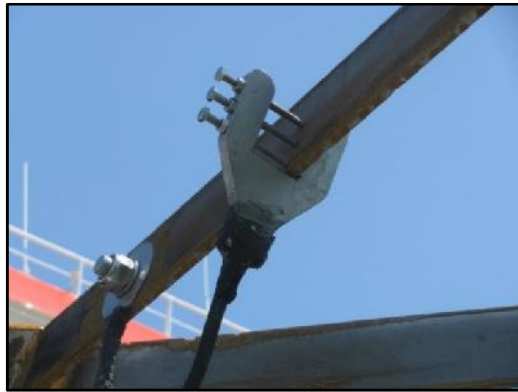
Figure 23 CPS Anode Pods; CPS Cable Connecting Clamp

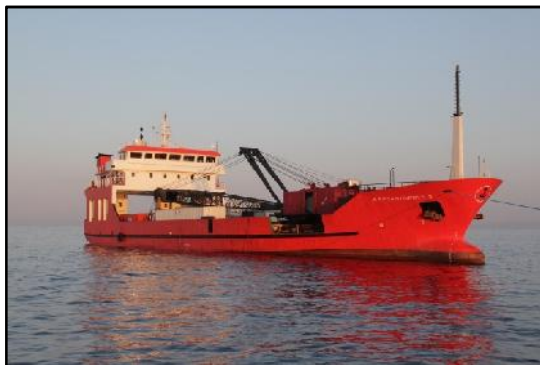
Figure 24 DSV In position; Laying the moorings

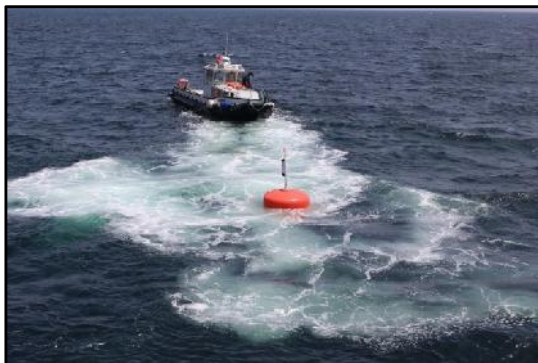
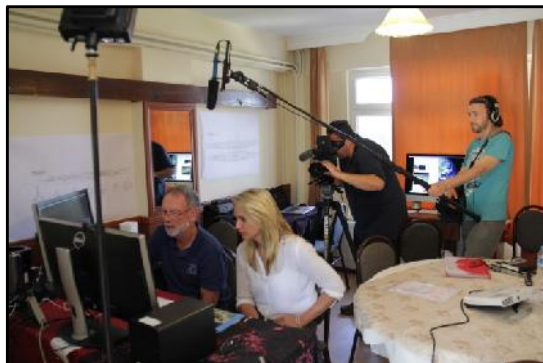
Figure 25 Temporary Buoy in position: Shore HQ film shoot
